Recall Bulletin

PRODUCT SAFETY RECALL

SUBJECT: Loss of Power Brake Assist in Extreme Cold Weather

MODELS: 2009-2010 Pontiac Vibe
With 1.8L Engine (RPO LAY)
Registered in Canada, Alaska, Colorado, Idaho, Illinois, Iowa, Kansas,
Maine, Michigan, Minnesota, Montana, Nebraska, Nevada, New
Hampshire, New York, North Dakota, South Dakota, Vermont, Wisconsin,
Wyoming

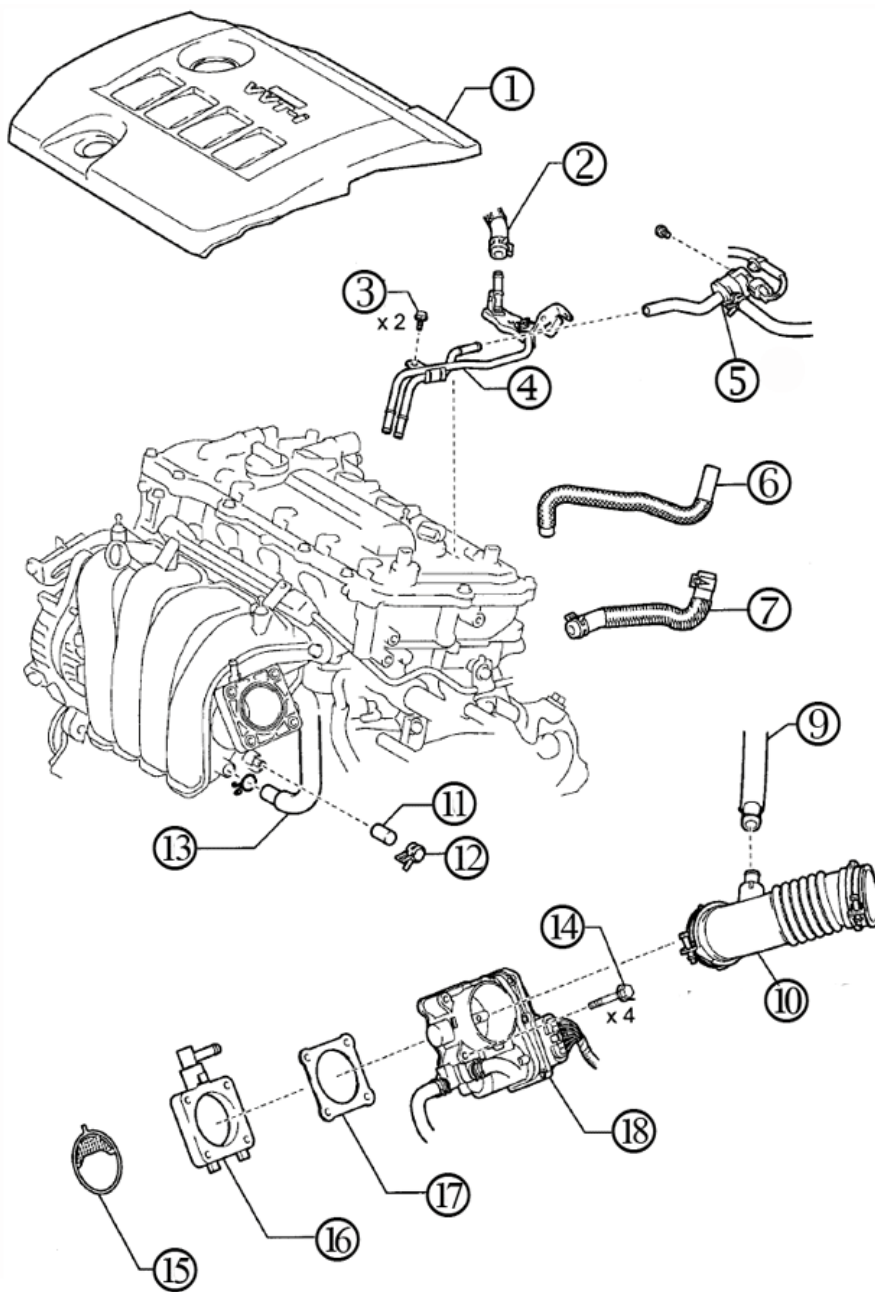
2327233

(1) No. 2 Cylinder Head Cover (2) Union-to-Connector Tube Hose (3) Fasteners (4) Air Tube (5) Duty Vacuum Switching Valve (6) No.1 Fuel Vapor Feed Hose (7) No. 1 Vacuum Transmitting Hose (9) No. 2 Ventilation Hose (10) No. 1 Air Cleaner Hose (11) Plug (12) Clip (13) Ventilation Hose (14) Bolts (15) Throttle Body Gasket (16) Intake Air Connector Assembly (17) Diesel Throttle Body Gasket (18) Throttle Body Assembly
