Federal Recall Information

09KWA

Kenworth Truck Company

Insufficient U-Bolt Torque on Airglide 400L Rear Suspension

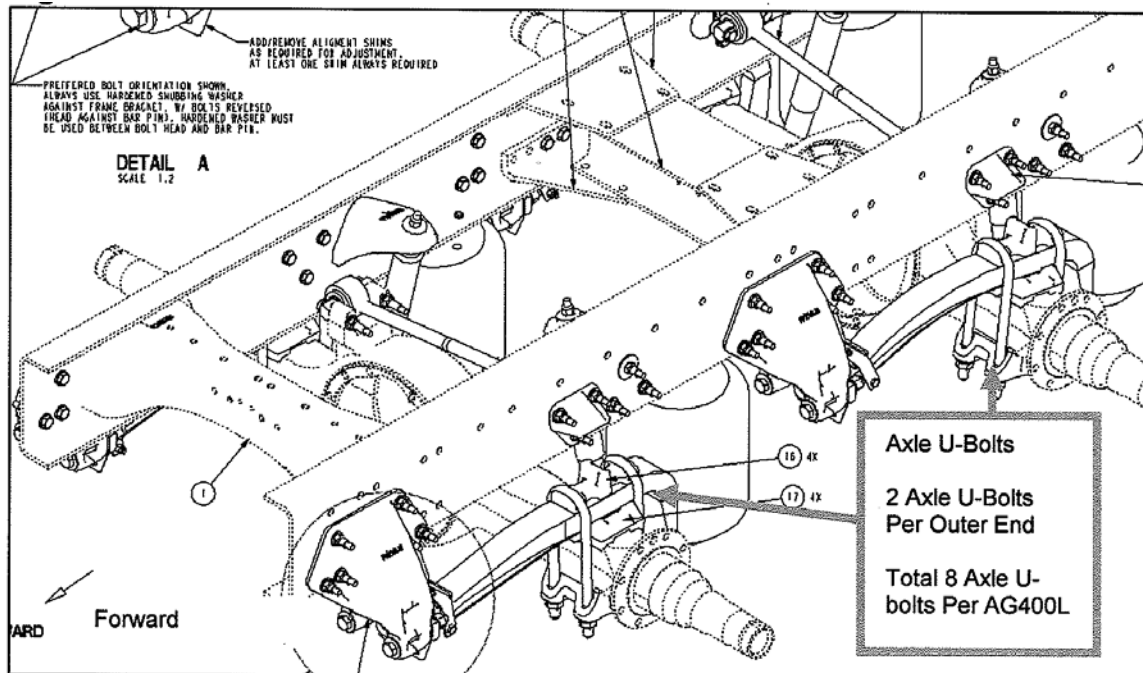
Fig. 1

The axle u-bolts attaching the axle to the suspension leaf spring on certain AG400L rear suspensions may have received insufficient fastener torque during the installation process (Ref. Figure 1 & 2). The insufficient torque may allow the axle U-bolt to become loose, which may cause vibration in the rear suspension. If multiple fasteners were to become loose, the U-bolt holding the axle may lose clamp load and the rear axle may shift relative to the rear suspension leaf spring, which might result in an accident. This condition was determined by Kenworth to be a safety-related defect.

The remedy of the recall will involve inspecting the axle u-bolts for visible defects including bent and/or smashed threads and re-torquing the axle u-bolts to factory specifications.
