SERVICE BULLETIN

Number: 09-002

EC Series Electrical System Mandatory Product Improvement

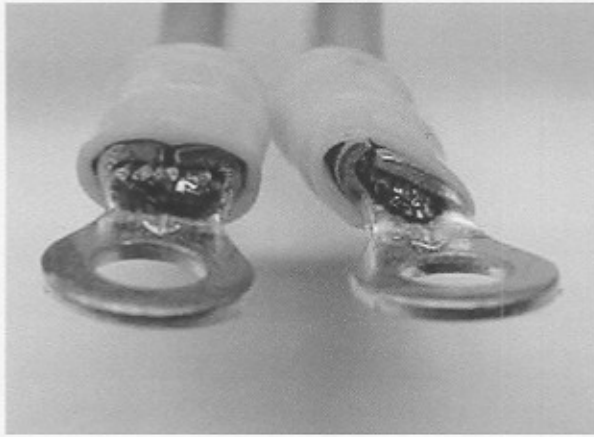
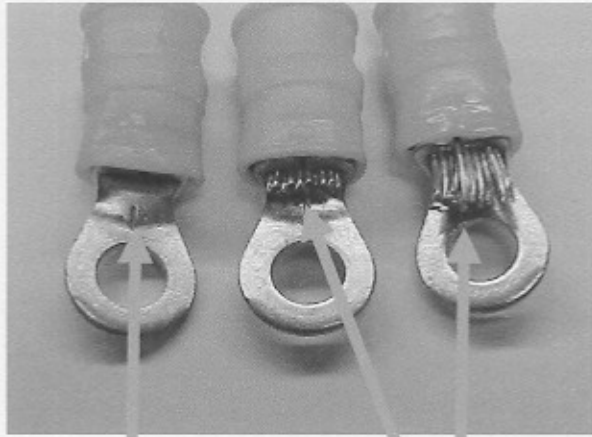
Fig 1

1. Crimps on the wires going to the terminal strip of the relay board should be uniform and tight. There should be no bare wire visible between the wire insulation and the terminal, and strands flush with terminal barrel. (Fig 1 & Fig 2)

Correct Position

Poor Position In Crimper

Correct

Poor Wire strands Too long

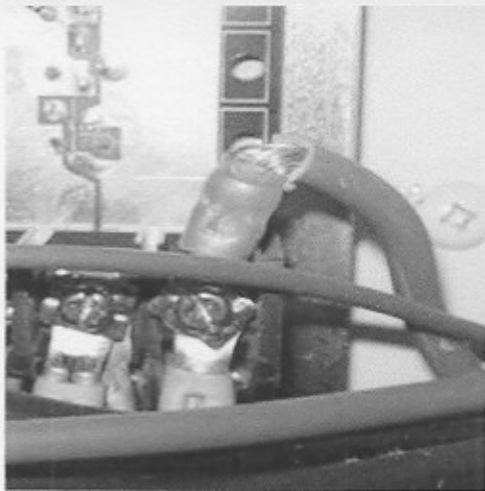
Fig 2

Poor Crimp

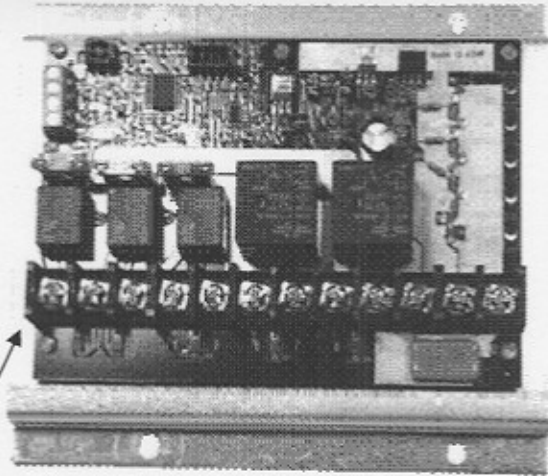
Fig 3

Torque all Torx type screws to 18 in/lbs

3. All screws on the terminal strip should be replaced with the Torx type screw, supplied in the product improvement kits for EC2.0, EC2.5 & EC3.0, and ***MUST BE*** torqued to 18 in/lbs. (a torque screwdriver is available on a loan basis, from Trans/Air) (Fig 3)

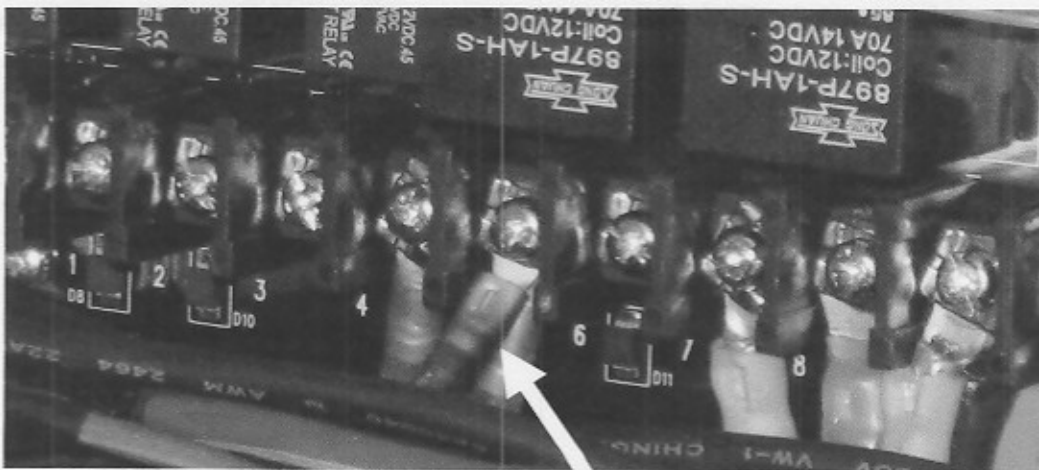
Fig 4

Heat discoloration of a poor (loose) crimp
