# TECHNICAL BULLETIN

No: J016  
Issue: 1  
Date: 30 OCT 2009

## **SAFETY RECALL: Fuel Transfer Tube**

**XF (X250) 4.2L V8 Only**

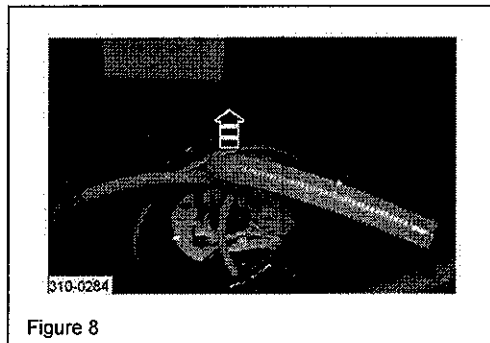
The fuel transfer tube has been incorrectly designed as it is 190mm too long. This results in a variable assembly condition which can lead to the fuel transfer tube becoming either kinked sufficiently to prevent fuel flow, or allow incorrect assembly by the fuel tank supplier, which can also lead to the fuel transfer tube being inserted too far into the FDM which again can restrict fuel flow.

16. Reposition the fuel transfer module transfer feed tube; cut away and discard 150mm (6 in) from the disconnected end of the tube. (Figure 8).
