**Subject: NHTSA Campaign - 09V424**

**2010 MY Jaguar XF Fuel Tank Transfer Pipe Recall (Jaguar Recall Number J016) - Updated Technical Bulletin**

No: J016  
Issue: 2  
Date: 04 NOV 2009

## **SAFETY RECALL: Fuel Transfer Tube**

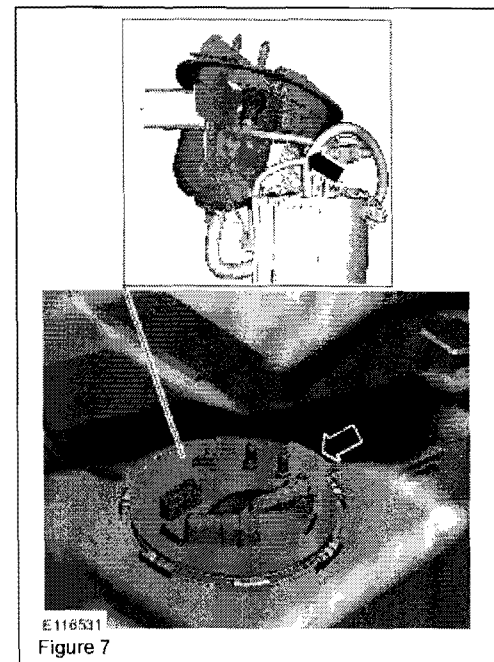
**Situation:** It is possible that the fuel transfer tube in the fuel tank assembly is kinked or the fuel transfer tube has been over-inserted into the in-tank fuel delivery module during fuel tank assembly. This may cause the vehicle to experience fuel starvation while indicating the presence of approximately one-quarter (¼) of a tank of fuel on the fuel gauge.

This kink in the fuel transfer tube or incorrect assembly of the fuel transfer tube into the fuel delivery module restricts fuel being transferred from one side of the fuel tank to the fuel pump causing fuel starvation at low fuel levels. Fuel starvation to the engine leads to engine stumble followed by engine cut-out with minimal warning and could potentially cause a crash.

15. Disconnect the fuel transfer module transfer feed tube. (Figure 7)
