Service Bulletin No. 335

MODEL D Series Coaches w/ Luminator Destination Signs	TYPE Field Change Program	SECTION/GROUP 3-Body	DATE Nov. 6, 2009
SUBJECT LUMINATOR HORIZON LED SIDE DESTINATION AND ROUTE SIGNS			
CONDITIONS

Ref. NHTSA Luminator Recall No.: 09E-054

**FIELD MODIFICATION INSTRUCTIONS
FOR
HORIZON SIDE SIGN OPEN CONNECTOR INSTALLATION
AND CONNECTOR PWA REPLACEMENT**

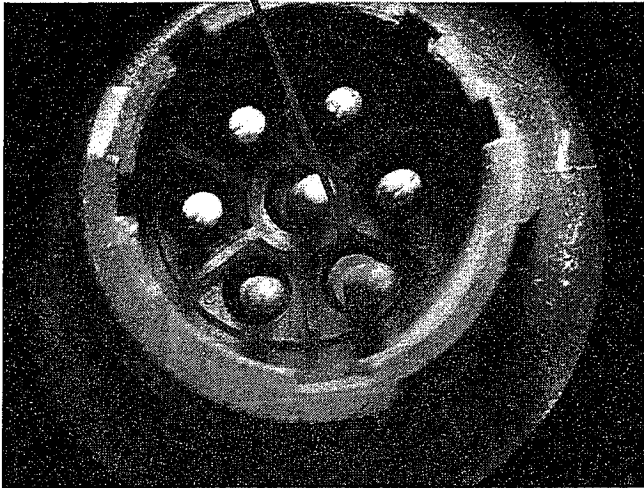
Corrosion on Open Connector

The corrosion is caused by an accumulation of moisture under the connector. None of the connectors which have a cable attached to them show any sign of corrosion. The base of the connector is too close to the board to effectively coat the solder connections with conformal coating (a corrosion preventative). This corrosion creates the conductive path between battery voltage and ground pins. Certain cleaning practices, (i.e. spraying water and cleaning agents) used at the Transit Authorities facilities introduces more moisture into the connector and increases the likelihood of the corrosion.

On all buses built since 2008, there has been no evidence of corrosion. By cleaning the connector with a moisture displacing corrosion inhibitor and subsequently capping the open connector with a vinyl cap, the conditions that allow the moisture to ingress and produce the corrosion will be eliminated.

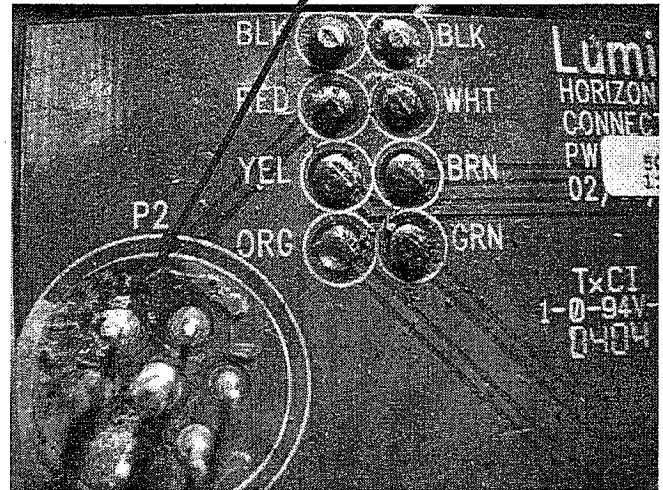
Corrosion on board under connector

On all buses built before 2008 (2001-2007 inclusive) the connector board will be replaced with a newly designed board. The new board eliminates the possibility of arcing by putting the ground and battery voltage on separate layers of the board. The traces have also been moved to allow the maximum spacing. In addition conformal coating has been applied below the connector and a cap is installed on all open connectors to prevent the incursion of moisture and debris which would allow corrosion to develop.

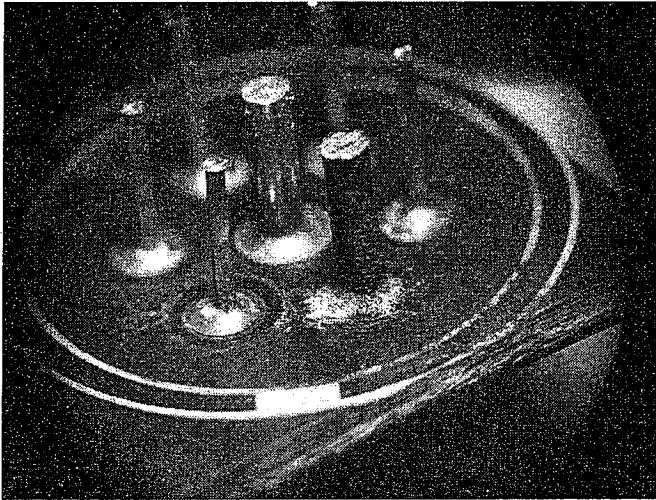
The photos below (taken from the sample population) show the impact of the corrosion on the board itself after the connector barrel has been removed.

Corrosion Starting on Battery Voltage Pin

This corrosion will allow a potential short and the sign will fail. In rare instances, this corrosion will cause the sign to smoke and possibly flame.

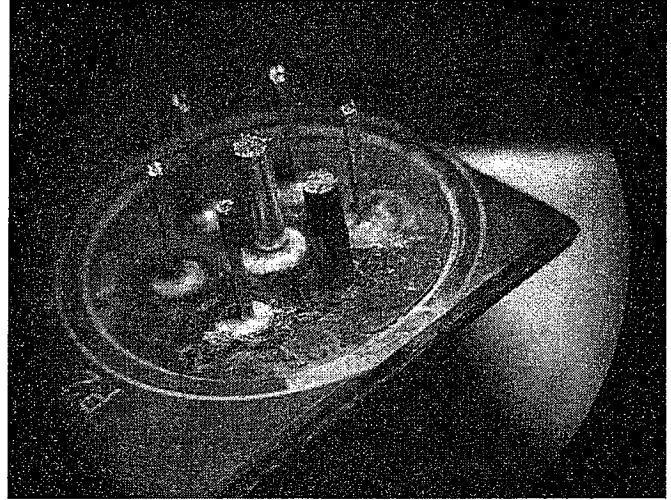
Corrosion advanced to a conductive condition
