PRELIMINARY INSPECTION INSTRUCTIONS

SPECIAL SERVICE CAMPAIGN

**Rear Frame Cross Member &
Load Sensing Proportioning & By-Pass Valve Inspection**

2000-2003 Model Year Tundra

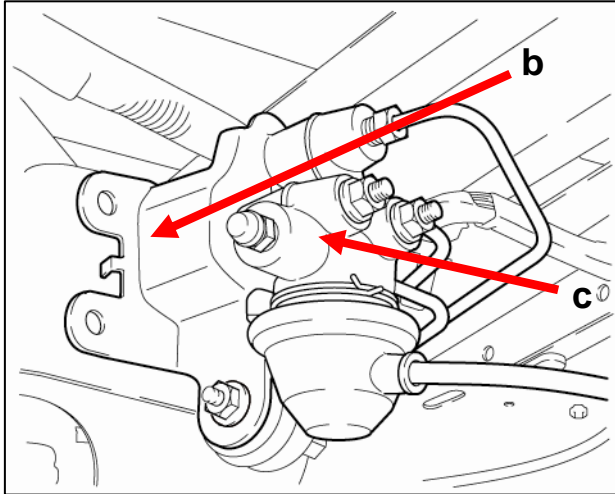
Figure 5

1. Inspect the Load Sensing Proportioning & By-Pass Valve (LSP & BV) for excessive rust, looseness & normal function.
 - a. If there are signs of excessive rust and/or any sign of brake fluid leakage, note that the valve will require replacement and continue inspection.
 - b. With one hand using minimal force, attempt to wiggle the **valve bracket (b)**.
 - i. If the LSP & BV bracket is loose, note that the LSP & BV and bracket will require replacement and continue inspection.
 - c. With one hand using minimal force, attempt to wiggle the **valve body (c)**.
 - i. If the LSP & BV body and/or associated components are loose or show any signs of leakage, note that the LSP & BV and bracket will require replacement.

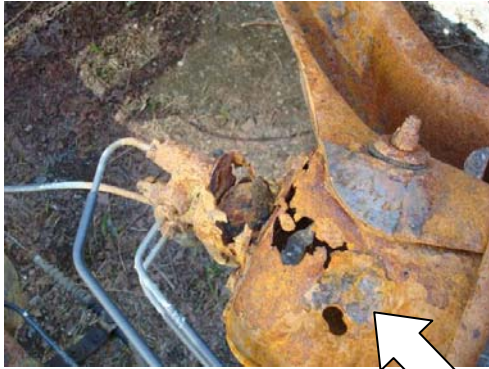
Gusset Area

Guideline: Any perforation in gusset area

- Rear LH Shock absorber mounting area
- LSP&BV Bracket installation area

Example of NG Condition: Replace Rear Cross Member

Vehicle should not be driven without rear cross member replacement

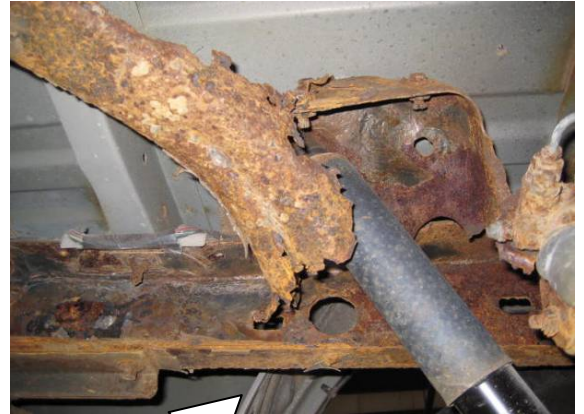
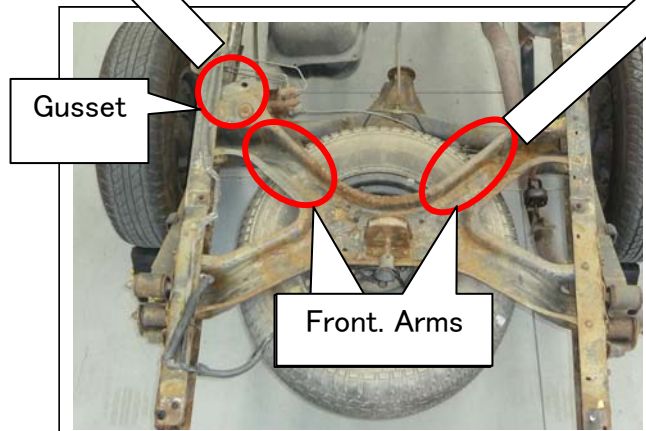
Rear Cross Member - Front Arm Area

Guideline: The length of perforation is more than 2/3 of the cross-section length of the cross-section length

Example of NG Condition: Replace Rear Cross Member

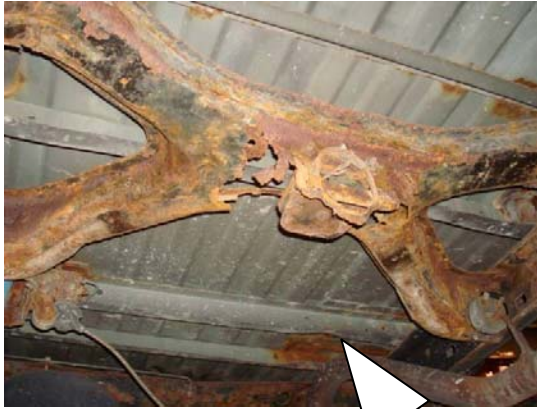
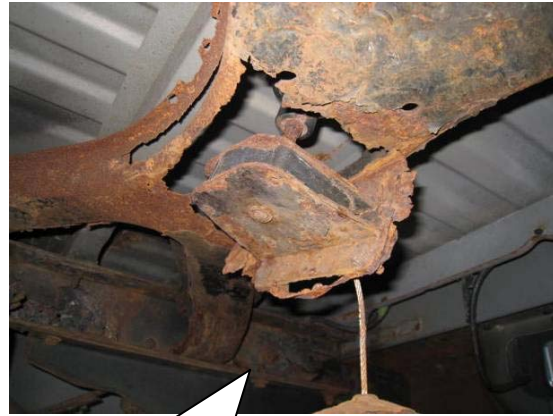
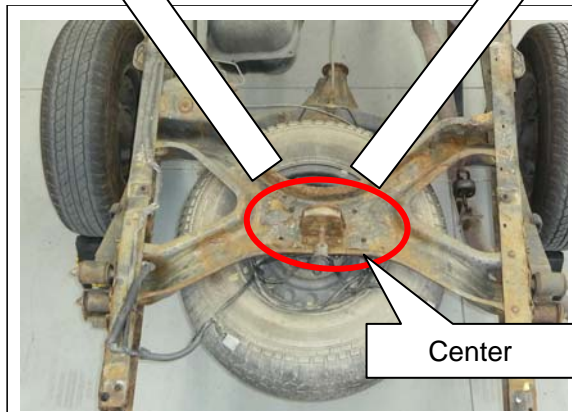
Area: Rear Cross Member - Center Portion

Guideline: The length of perforation is more than $\frac{2}{3}$ of the cross-section length

Example of NG Condition: Replace Rear Cross Member

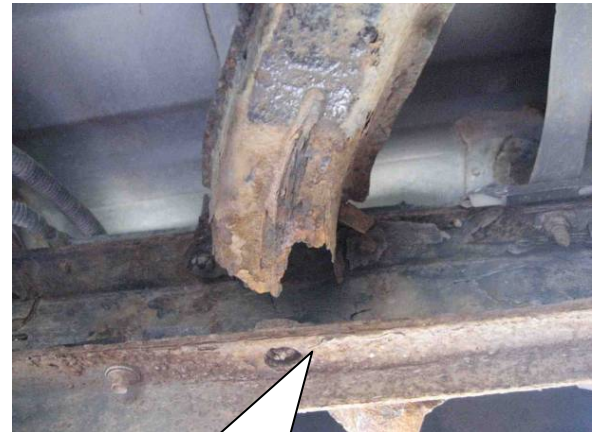
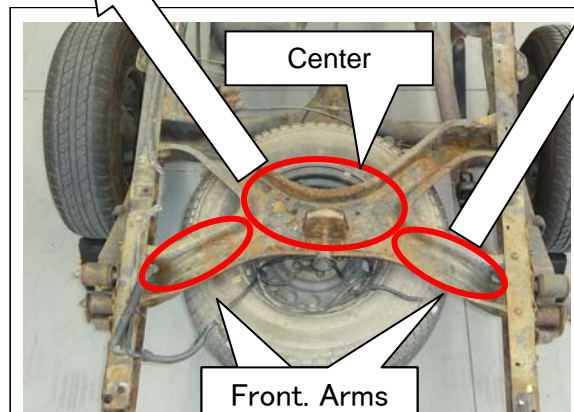
Area: Rear Cross Member - Front Arm Portion

Guideline: if a **complete breakage/separation from side rail is** observed in rear arm of the cross-member, spare tire should be removed and secured in bed of truck.

Example of NG Condition: Necessary to replace Rear Cross Member
