Subject: Safety Recall (Special Service Campaign) – 90M
Certain 2000 – 2003 Model Year Toyota Tundra Vehicle in Severe Cold Climate States
Excessive Corrosion of the Rear Cross Member (Spare Tire Carrier)
Phase I – 20 Severe Cold Climate States

**SSC 90M – Certain 2000 through 2003 Tundra Vehicles
Severe Corrosion of the Rear Cross-Member
Safety Recall Notice (Interim Notice)**

**Special Service Campaign (Safety Recall) Q&A
Certain 2000 through 2003 Toyota Tundra Vehicles
Severe Corrosion of Rear Cross-Member**

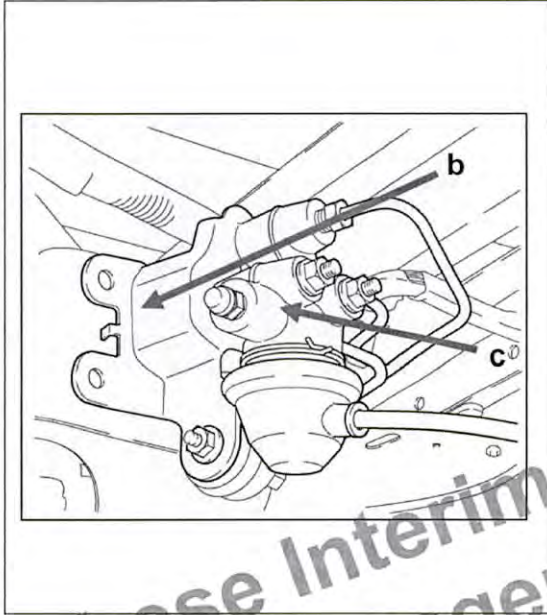
C. LOAD SENSING PROPORTIONING & BY-PASS VALVE AND ASSOCIATED BRAKE LINE INSPECTION

1. Inspect the Load Sensing Proportioning & By-Pass Valve (LSP & BV) for excessive rust, looseness & normal function.
 - a) If there are signs of excessive rust and/or any sign of brake fluid leakage, note that the valve will require replacement and continue inspection.
 - b) With one hand using minimal force, attempt to wiggle the **valve bracket (b)**.
 - i. If the LSP & BV bracket is loose, note that the LSP & BV and bracket will require replacement and continue inspection.
 - c) With one hand using minimal force, attempt to wiggle the **valve body (c)**.
 - i. If the LSP & BV body and/or associated components are loose or show any signs of leakage, note that the LSP & BV and bracket will require replacement and continue inspection.

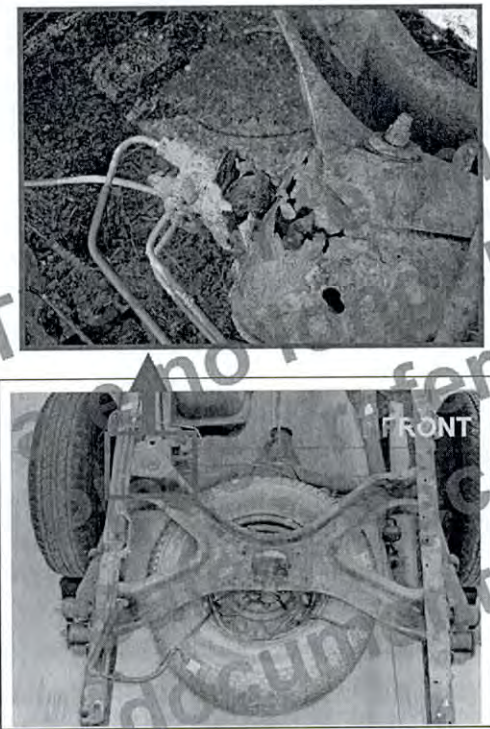
Vehicle should not be driven without rear cross member replacement

<p>Gusset Area</p> <p>Guideline: Any perforation in gusset area</p> <ul style="list-style-type: none"> - Rear LH Shock absorber mounting area - LSP&BV Bracket installation area <p>Example of NG Condition: Replace Rear Cross Member</p>

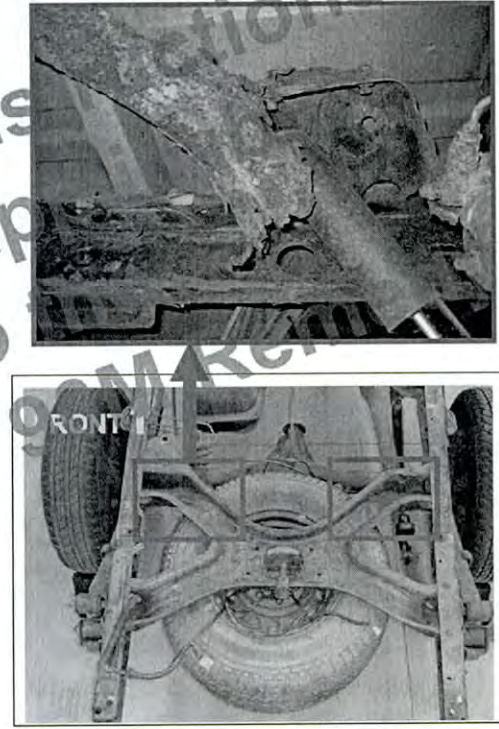
<p>Rear Cross Member - Front Arm Areas</p> <p>Guideline: The size of the perforation is more than 2/3 of the cross section length</p> <p>Example of NG Condition: Replace Rear Cross Member</p>

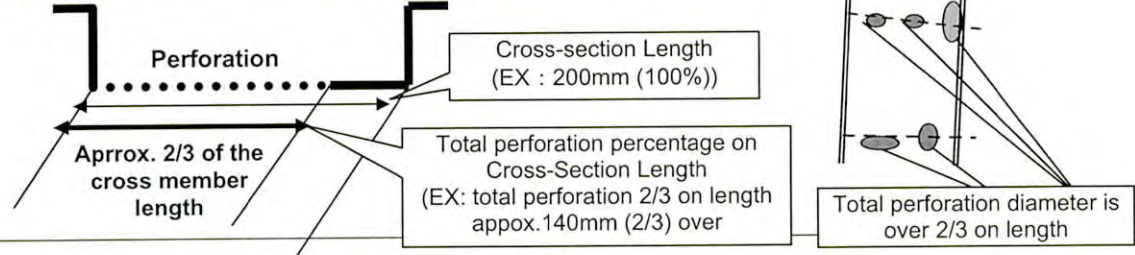
Rear Cross Member - Front Arm Cross Section

(NOTE) Explanation of the meaning of "The length of perforation is more than 2/3 of the cross section length"

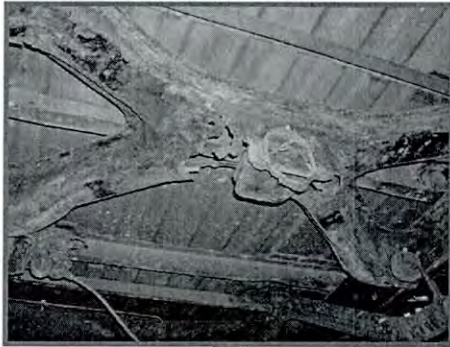
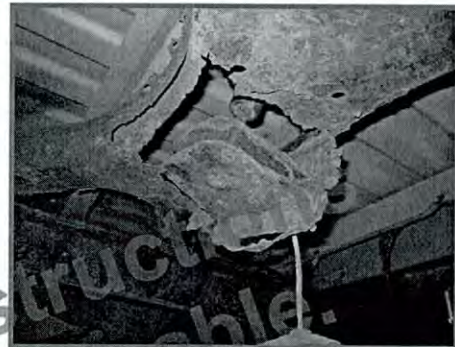
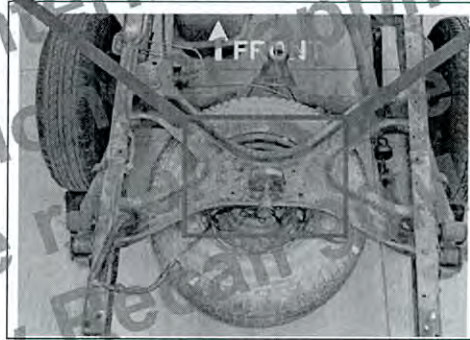
Vehicle should not be driven without rear cross member replacement

Guideline: The size of the perforation is more than 2/3 of the cross section length

Example of NG Condition: Replace Rear Cross Member

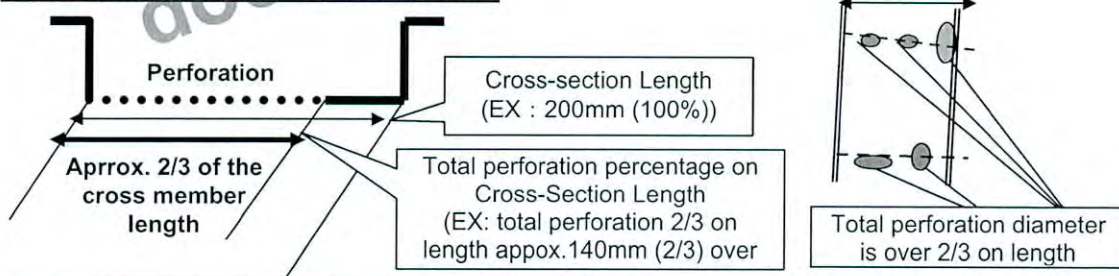
Rear Cross Member - Center Cross Section

"The length of perforation is more than 2/3 of the cross-section length"

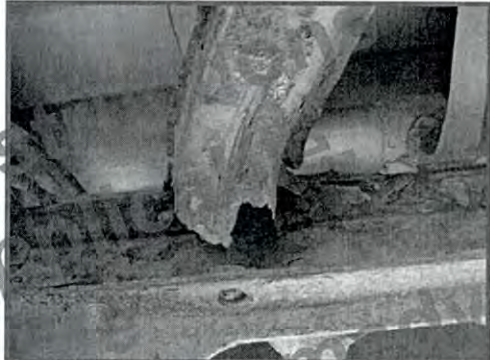
Rear Cross Member - Center Portion	Rear Cross Member - Rear Arm Area
<p>Guideline: Perforation exceeds 30 mm diameter or more than 3 perforated spots in the center portion of the rear cross member.</p>	<p>Guideline: if a complete breakage/separation from side rail is observed in rear arm of the cross-member, spare tire should be removed and secured in bed of truck.</p>
<p>Example of NG Condition: Spare tire should be removed and secured in bed of truck.</p>	<p>Example of NG Condition: Necessary to replace Rear Cross Member</p>
<p>NG Case 1: perforation exceeds 30mm diameter</p>

<div data-bbox="516 688 787 787" style="border: 1px solid black; padding: 5px; display: inline-block;"> <p>Single perforation over 30mm</p> </div>

Vehicle can be driven without rear cross member replacement however; spare tire must be removed from carrier and secured in truck bed.

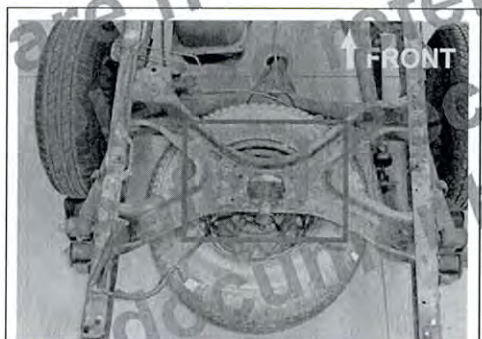
Spare tire can remain stowed in carrier and it is not necessary to replace rear cross member
