**Recall Information Bulletin**

**No:** C1004110 **Issued:** 2/17/2010  
**NHTSA No:** 09V-449  
**Transport Canada No:** 09-325  
**Re:** Air Intake Duct  
**Group:** 15 **Models:** FE,FG

Safety Recall C1004110 - Air Intake Duct

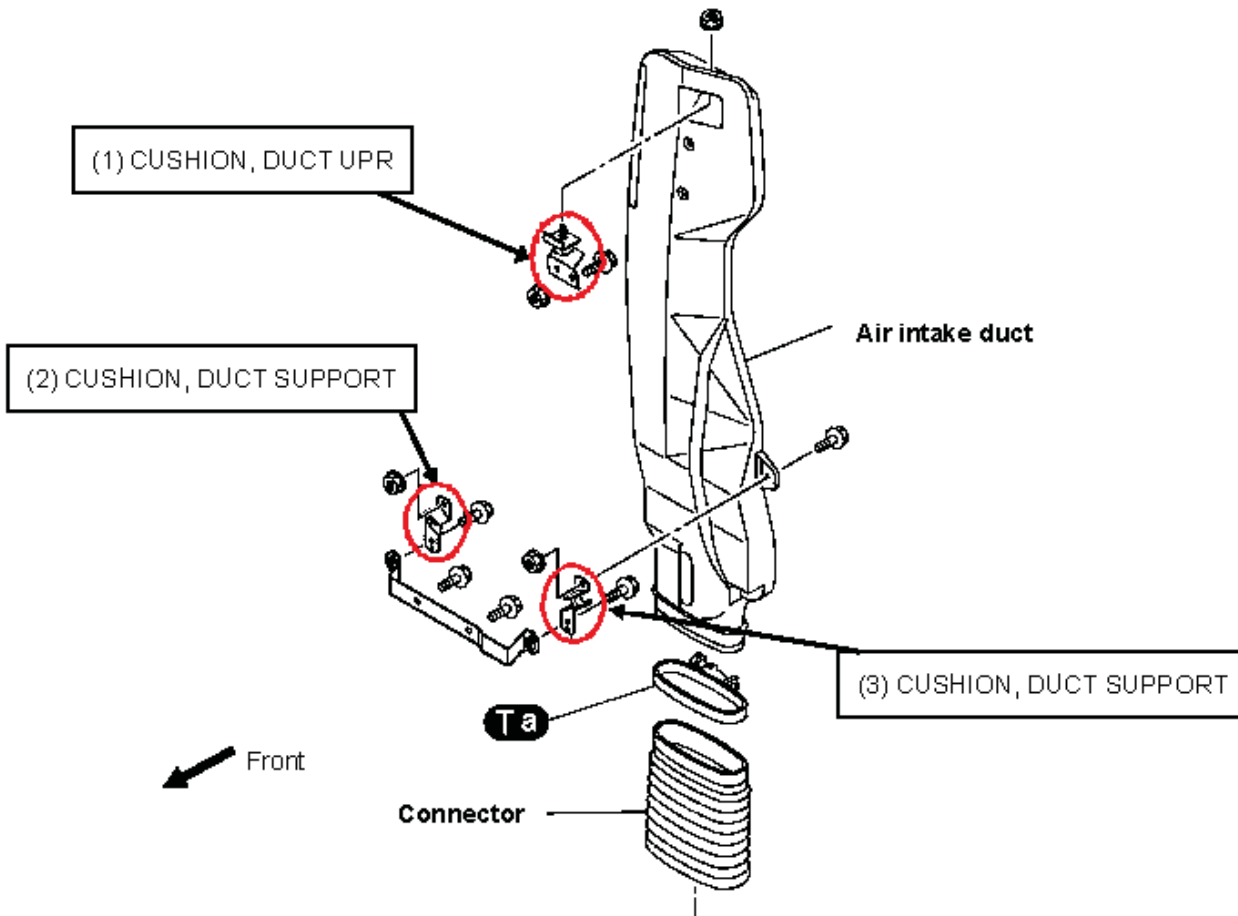
Mitsubishi Fuso Truck of America, Inc. has decided that a defect which relates to motor vehicle safety exists in the air intake bracket rubber cushions. On affected vehicles, the weather resistance properties of the air intake duct rubber cushions are insufficient. During normal vehicle operation, the rubber cushions deteriorate and crack, causing abnormal noise. In the worst case, all of the rubber cushions could crack, allowing the air intake duct to fall off of the truck.

Kit # EX54A		
Item #	Part Name	Qty
1	Cushion, Duct Upper	1
2	Cushion, Duct Support	1
3	Cushion, Duct Support	1

1. Park the vehicle on a flat, level surface, shut off the engine, apply the parking brake, chock the wheels and disconnect the battery cables. **CAUTION! Do not remove the wheel chocks until all modification work has been completed!**
2. Remove the air intake duct. Replace the upper duct cushion and two duct support cushions.
3. Tighten all hardware in accordance with the Tightening Torque Table below.

Parts to be tightened	Tightening Torque
Air Intake Duct Clamp (Ta)	2.2 to 2.5 ft.lbs. (3.0 – 3.4 Nm)
M6 Bolts	3.0 to 4.4 ft.lbs. (4.0 – 6.0 Nm)
M8 Bolts	7.4 to 11.1 ft.lbs. (10.0 – 15.0 Nm)
