**Daimler Trucks  
North America LLC****Recall Campaign**February 2010  
FL566A  
NHTSA #09V-452**Subject: Sterling 360 Air Intake Duct Cushions****Models Affected: Specific Sterling 360 vehicles manufactured  
January 25, 2006, through November 30, 2008.****General Information**

### Subject: Sterling 360 Air Intake Duct Cushions

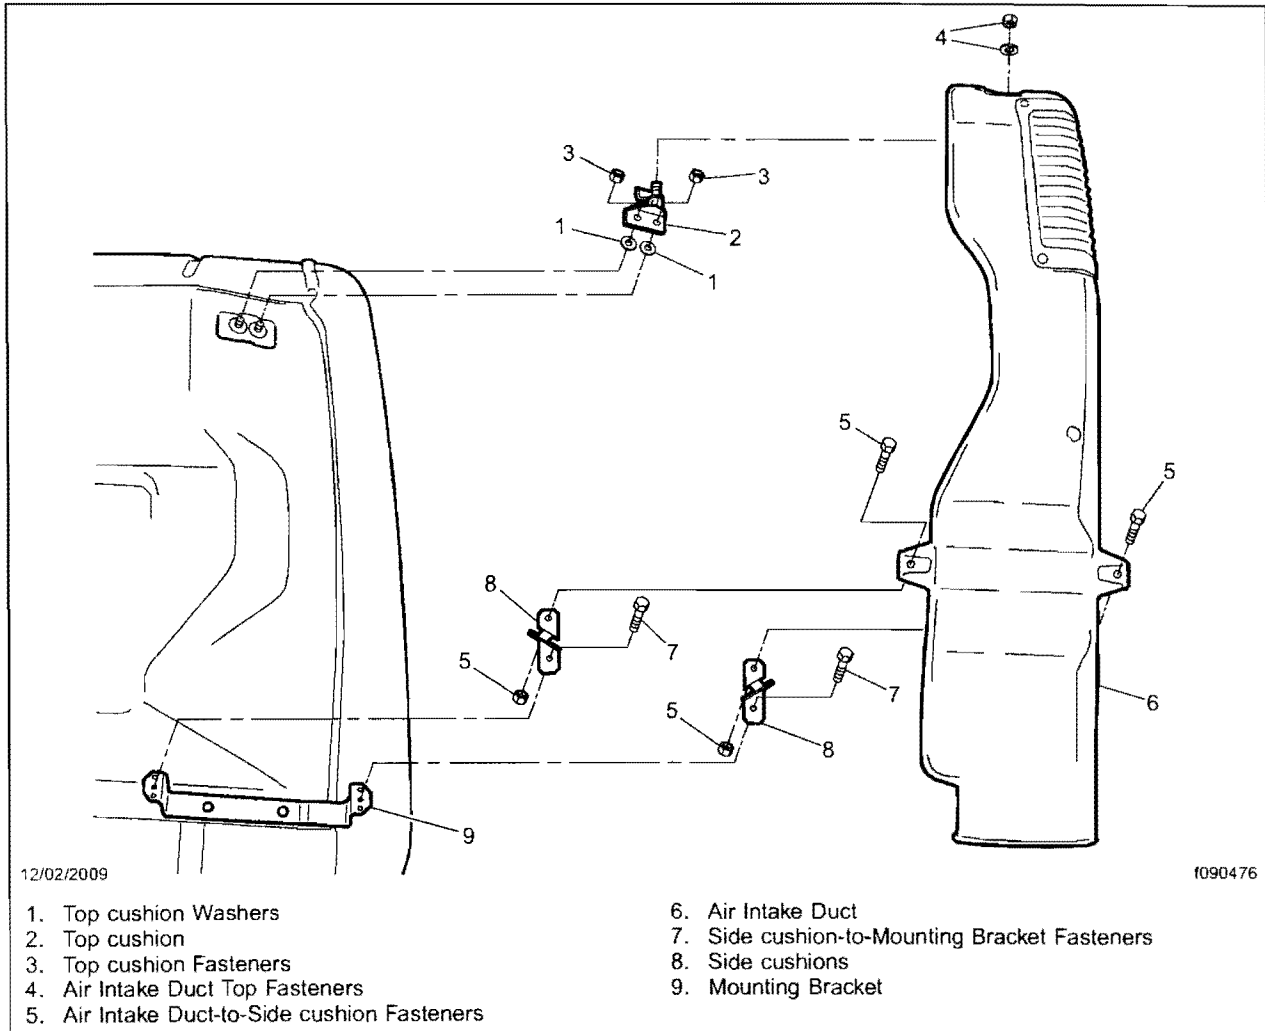
Fig. 1, Air Intake Duct Removal

The weather resistance properties of certain engine air intake duct rubber cushions is insufficient. During normal vehicle operation, the cushions may deteriorate and crack, causing abnormal noise. In the worst case, all of the rubber cushions could crack and break, allowing the air intake duct to separate from the vehicle, resulting in a possible road hazard or vehicle crash.

4. Tilt the cab.
5. Remove the air intake duct top mounting fasteners. See Fig. 1.
6. Remove the side cushion-to-mounting bracket fasteners and remove the air intake duct. Do not remove the air intake duct mounting bracket on the back of the cab.
7. Remove and discard the top cushion.
8. Remove and discard the side cushions from the air intake duct.
9. Install a new top cushion on the back of the cab.
10. Install two new side cushions on the air intake duct.
11. Mount the air intake duct on the mounting bracket. Install and tighten the side cushion-to-mounting bracket fasteners.
