CERTAIN 2009 MODEL YEAR F-650/750 VEHICLES – CHASSIS WIRING HARNESS CONNECTOR SEAL

OVERVIEW

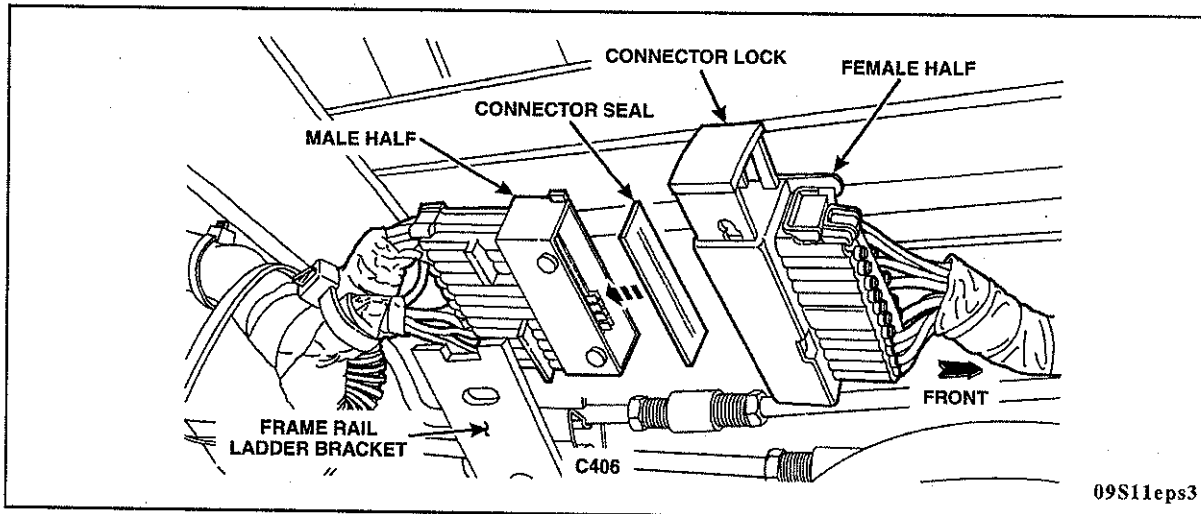
FIGURE 2

1. Make sure all electrical loads (lights, ignition, and accessories) are turned OFF. Remove the key from the ignition.
2. Remove any tie straps that secure C406 to the frame rail ladder bracket.
3. Release the connector lock and separate the front and rear main chassis harness at C406. Inspect the male half of the connector for the seal. See Figure 2.

- If the seal is **PRESENT** at C406, connect the front and rear main chassis harnesses and proceed to the Service Procedure, Step 5.
 - If the seal is **NOT PRESENT** at C406, proceed to step 4.
4. Inspect each half of C406 for evidence of corrosion.
 - If **NO evidence of corrosion is found**, proceed to the Service Procedure.
 - If **ANY evidence of corrosion is found**, this is considered related damage. Please call the Special Service Support Center (SSSC) at 1-800-325-5621 for further instructions.

Install the **new** seal on the male half of the connector.

- Align the slots of the seal with the terminal pins.
- Using gentle pressure, push the seal downward onto the terminal pins until the seal seats in the bottom of the connector cavity. See Figure 2.
