Safety Recall Circular

Code: 70D4
Subject: 2009 Q5
Replace Middle Clip of A-pillar Cover
December 2009
Claim Entry Procedure

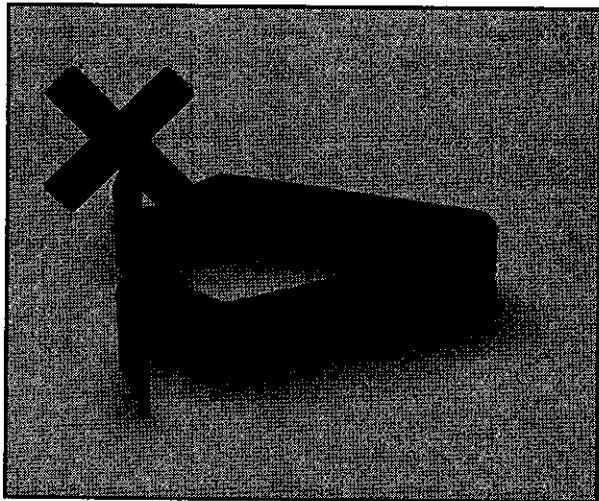
Tip: Old retaining clip (must be removed)
