Recall Bulletin

F/CMVSS NONCOMPLIANCE RECALL

SUBJECT: Heating and Windshield Defrost Inoperative – Replace Computer Module

MODELS: 2010 Chevrolet Equinox
2010 GMC Terrain

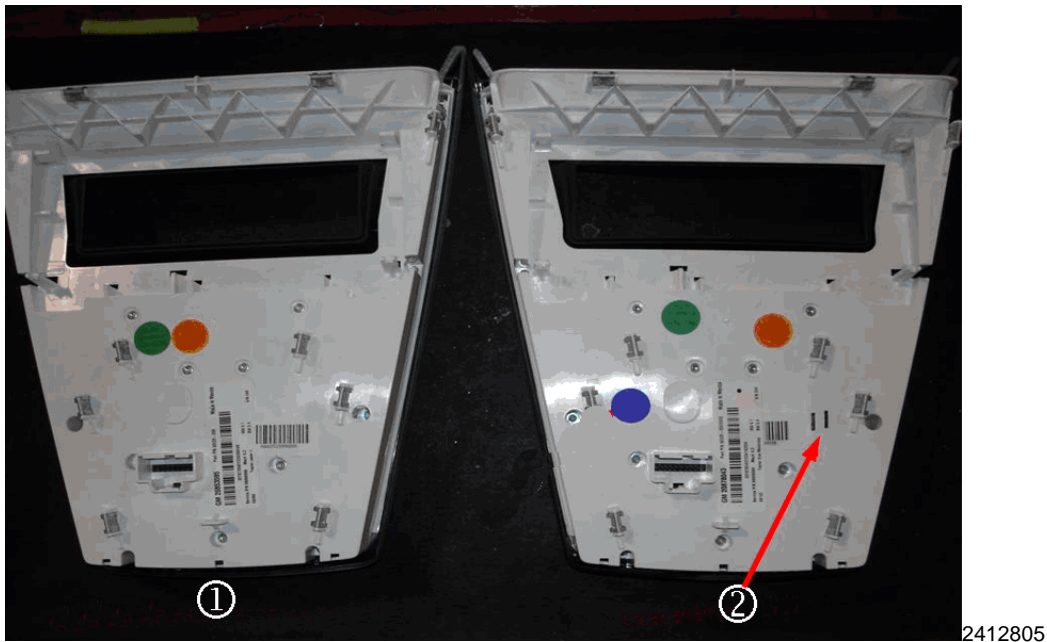
(1) First Design Radio Control Assembly (2) Second Design Radio Control Assembly

1. Determine if the radio control assembly is programmable. First Design radio control assemblies are NOT programmable and must go through the Radio Control Assembly Exchange Process.
 - First Design radio control assemblies (1) are NOT programmable. There are NO slots on the backside of the radio control assembly.
 - Second Design radio control assemblies (2) are programmable. They have two slots on the backside of the radio control assembly. If the radio control assembly is a Second Design assembly, proceed to Step 2.
