File In Section: Product Recalls  
Bulletin No.: 09298B  
Date: January 2010

# Recall Bulletin

**SUBJECT:** Heating and Windshield Defrost Inoperative – Replace Computer Module

**MODELS:** 2010 Chevrolet Equinox  
2010 GMC Terrain

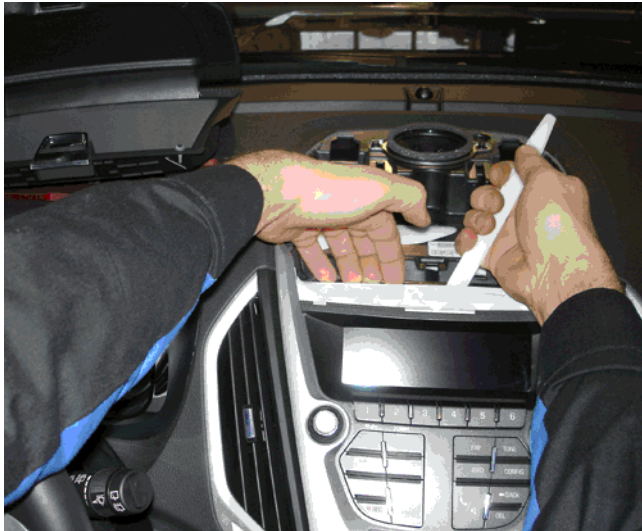
2383879

**Caution:** Insert a plastic body trim tool between the IP and radio control assembly along the top portion of the radio control assembly as shown in the illustration. **DO NOT** use a flat-blade screw driver to remove the radio control assembly.

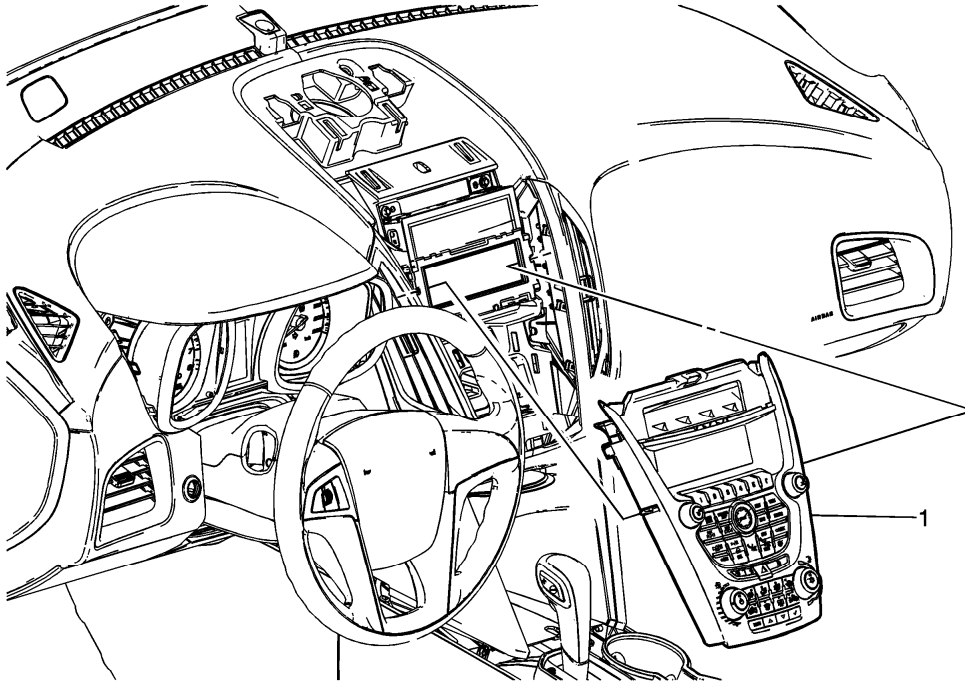
2244752

**Note:** For vehicles without the color touch screen navigation, unsnap and remove the display from the radio control assembly. Do not return the radio display with the radio control assembly.

1. Remove the radio control assembly (1). Refer to *Radio Control Assembly Replacement* in SI.
2. Package the radio control assembly and ship it to the exchange center indicated on the prepaid Federal Express overnight label that was enclosed with the exchange unit **within 24 hours**.

3. Install the radio control assembly. Refer to *Radio Control Assembly Replacement* in SI.
