MOTOR COACH
INDUSTRIES

SUBJECT: RECALL - TAG AXLE / DRIVESHAFT INTERFERENCE

Service Bulletin No. 277C

Service Bulletin No. 320

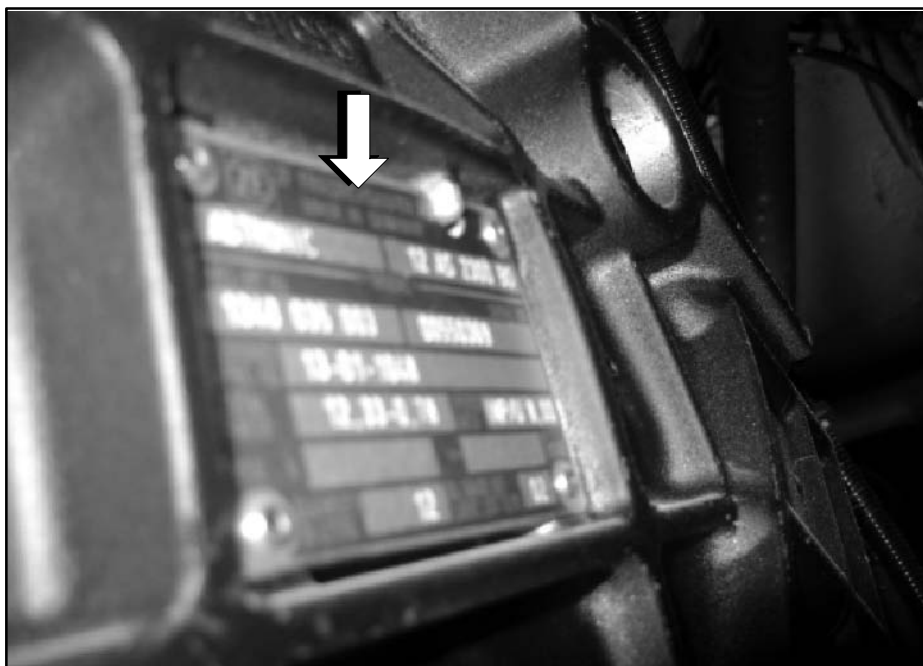
Figure 5. ZF transmission serial number plate.

24. Carefully align and apply the applicable decal, p/n 13-01-1096 **or** 13-01-1097 over the existing transmission serial number plate (refer to Figure 5). Discard other decal.

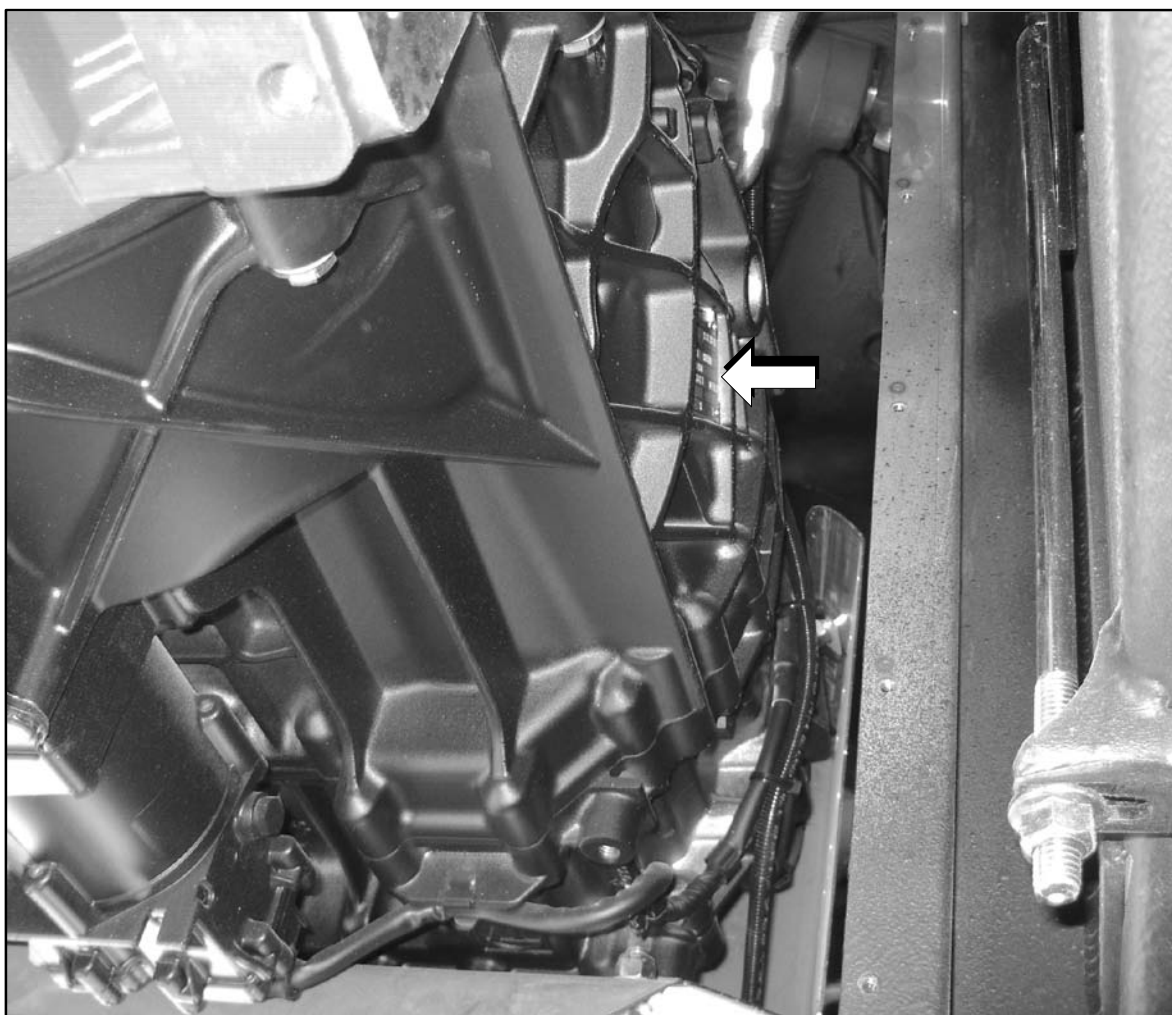
Figure 6. Location of ZF transmission serial number plate, on curbside of coach.

21. Locate the blue w/ silver serial number plate on the curbside of the transmission (refer to Figures 5 and 6).
22. Using a clean cloth, remove all dirt from the face of the transmission serial number plate.
23. Using a 50/50 mixture of isopropyl alcohol and water, clean the face of the serial number plate.
