Recall Bulletin

F/CMVSS NONCOMPLIANCE RECALL

SUBJECT: Shift Lever Indicator May Not Display Correct Gear

MODELS: 2009 Chevrolet Malibu
 2009 Pontiac G6
 2009 Saturn AURA
 Equipped with 4-Speed Transmission (RPO ME7/MN5)

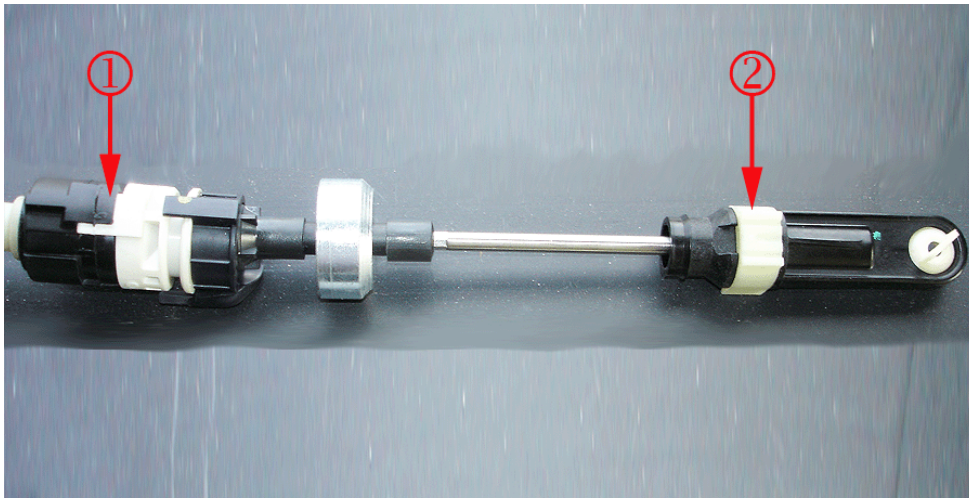
2269489

- (1) Shift Cable Locking Tabs
- (2) Shift Cable Adjuster Locking Clip

1. Open the hood and locate the transmission shift cable.
2. Determine if the transmission shift cable locking tabs are fractured and separated.

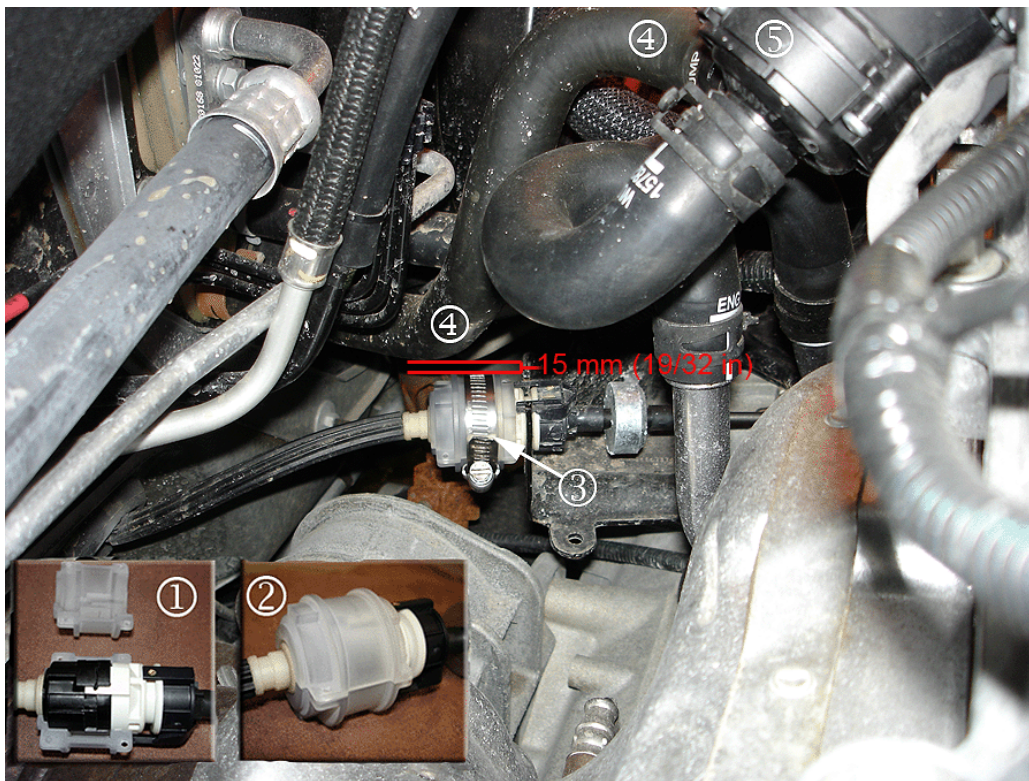
2269484

- (1) Clam Shell in Two Pieces
- (2) Clam Shell Around Shift Cable Locking Tabs
- (3) Clamp on Clam Shell
- (4) Inlet Coolant Hose and
- (5) Heater Cooler Pump.

3. Install the clam shell (1) (2) over the shifter cable locking tabs.
4. Install the service clamp over the clam shell (3). Position the clamp fastener head away from the inlet coolant hose (4). **Tighten the clamp to 4 N·m (35 lb-in).**
5. Ensure that there is 15 mm (19/32 in) of clearance between the inlet coolant hose (4) and the clam shell (3). On hybrid equipped vehicles, it may be necessary to reposition the inlet coolant hose (4) to achieve the required 15 mm (19/32 in) of clearance. **To reposition the inlet coolant hose (4) on hybrid equipped vehicles, locate the heater cooler pump (5) and perform Steps 5.1-5.4.**

Caution: Do not kink or damage the inlet coolant hose (4) when repositioning the hose to obtain the 15 mm (19/32 in) clearance. To avoid damaging the hose clamp, use J-38185 or equivalent hose clamp pliers to loosen the hose clamp.

- 5.1. Using J-38185 or equivalent hose clamp pliers, loosen the inlet coolant hose (4) connected to the heater cooler pump (5). Note the location of the clamp on the inlet coolant hose (4).
- 5.2. Rotate the inlet coolant hose (4) clockwise until 15 mm (19/32 in) of clearance between the inlet coolant hose (4) and clam shell (3) is achieved.
- 5.3. Ensure that the inlet coolant hose clamp is secure on the inlet coolant hose (4) in the production location.
- 5.4. Install the generator control module cover. Refer to *Generator Control Module Cover Replacement* in SI.
