# Recall Bulletin

**SUBJECT:** Engine Compartment Fire

**MODELS:** 1997-2003 Buick Regal  
2000-2003 Chevrolet Impala  
1998-1999 Chevrolet Lumina  
1998-2003 Chevrolet Monte Carlo  
1998-1999 Oldsmobile Intrigue  
1997-2003 Pontiac Grand Prix  
Equipped with a 3.8L V6 Naturally Aspirated Engine (RPO L36 - VIN K)

GM Recall #09047

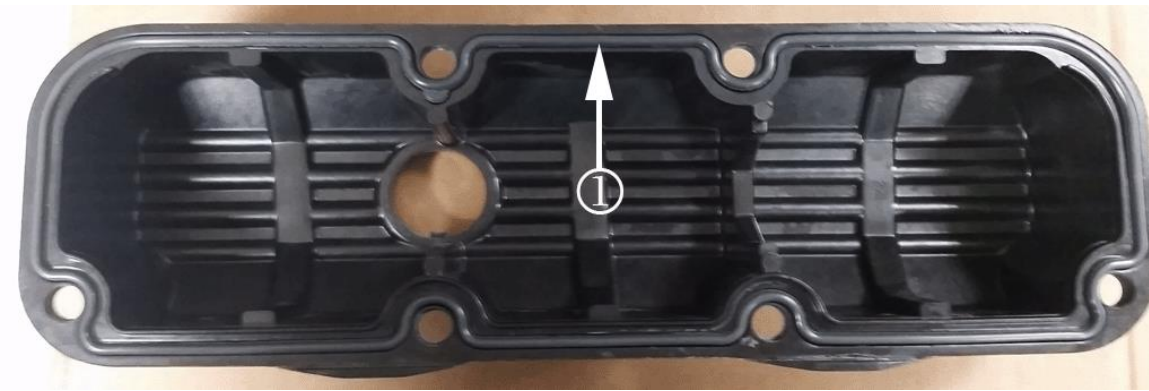
4596904

**Warning:** Ensure the new valve cover gasket is fully seated into the new valve cover groove. Use due care when installing the valve cover and gasket to the engine ensuring not to bump the valve cover or drag it over top of the rocker arms causing the gasket to come out of the groove. Inspect the mating surfaces of the valve cover and cylinder head to ensure the valve cover gasket is installed properly. Failure to do so may result in an oil leak and/or an engine fire.

6. Install a new left or front valve cover gasket (1) into the new valve cover and make sure that the valve cover gasket is seated properly in the valve cover groove.
  - 6.1. Install the six valve cover bolts and the six grommets into the valve cover.
  - 6.2. Apply medium strength thread lock compound (blue) to the six valve cover bolt threads.
  - 6.3. Install the NEW valve cover and gasket (1) to the cylinder head.
  - 6.4. Tighten the valve cover bolts to 10 Nm (89 lb in).
  - 6.5. Verify that the valve cover gasket is properly installed (see the warning above).
7. Install the 1-3-5 spark plug wires to the ignition coils.

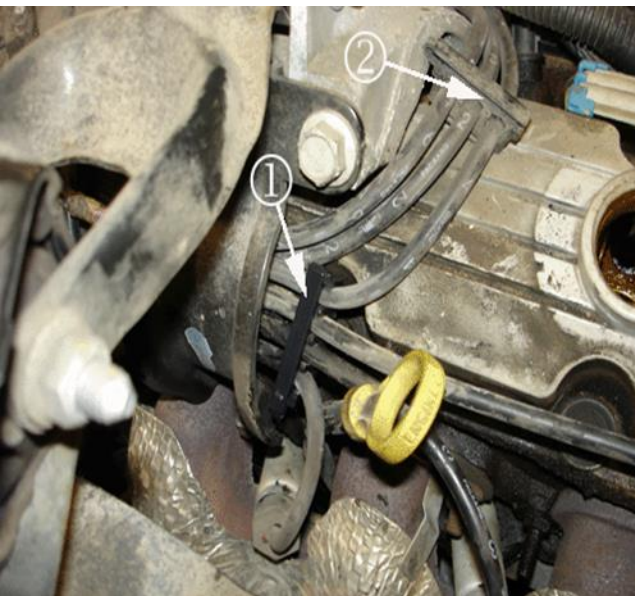
2257359

**Note:** Do NOT position the retainers above an exhaust runner.

8. Ensure that spark plug retainer (1) is connected to spark plug wire 4 and spark plug wires 1, 3, and 5. Make sure that spark plug wires 2, 4 and 6 are secured to the original retainers and under the left engine mount strut bracket (2). Verify the spark plug retainers are secured (completely latched) and they are NOT touching or over an exhaust runner.

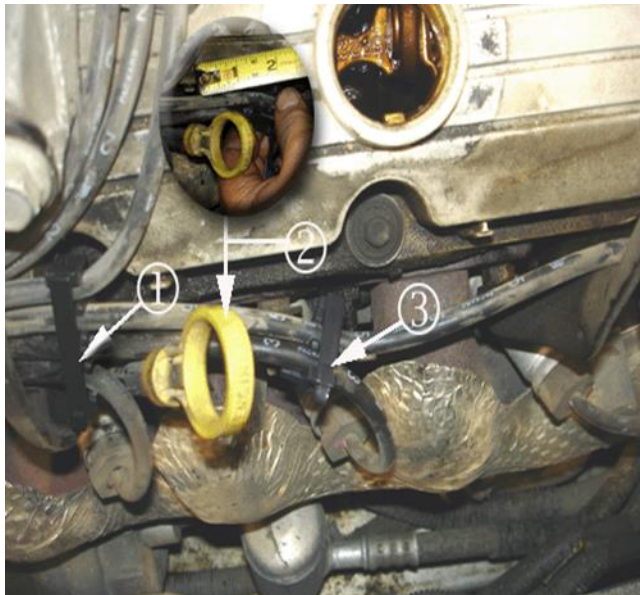
2257363

**Note:** Do NOT position the retainers above an exhaust runner.

9. Ensure that spark plug wires 3 and 5 are routed behind the oil level indicator and lift bracket. Verify that spark plug retainers (1 and 3) are positioned above the #1 and #3 cylinder spark plug wire boots as shown above. Verify that spark plug retainer (3) is approximately 50mm (2 in) from the oil level indicator (2). Verify the spark plug retainers are secured (completely latched) and they are NOT touching or over an exhaust runner.
