Bulletin No.: 09047D
Date: September 2016

PRODUCT SAFETY RECALL

SUBJECT: Engine Compartment Fire

MODELS: 1997-2003 Buick Regal
2000-2003 Chevrolet Impala
1998-1999 Chevrolet Lumina
1998-2003 Chevrolet Monte Carlo
1998-1999 Oldsmobile Intrigue
1997-2003 Pontiac Grand Prix
Equipped with a 3.8L V6 Naturally Aspirated Engine (RPO L36 - VIN K)

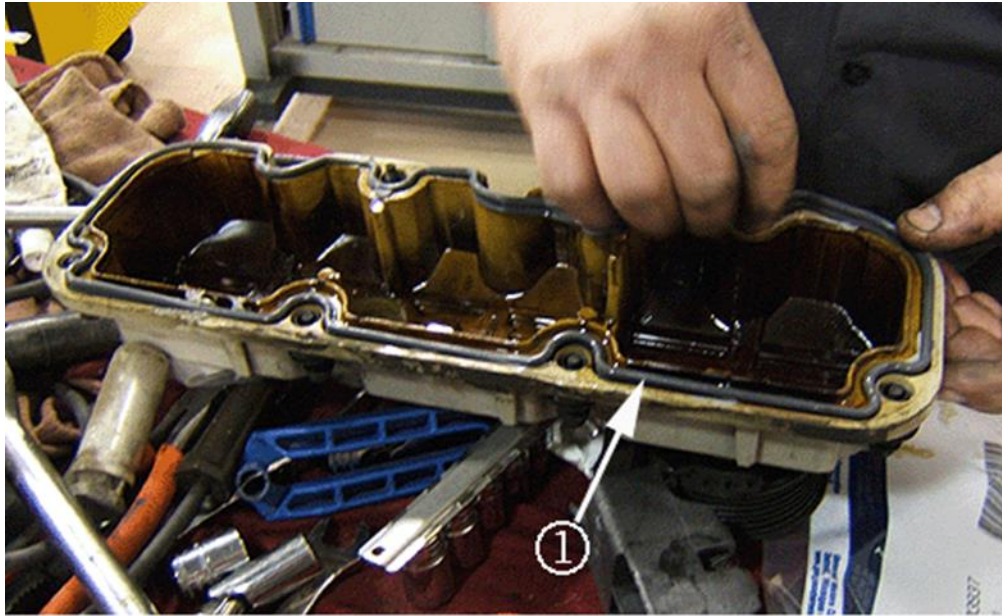
2076766

Warning: Ensure the new valve cover gasket is fully seated into the new valve cover groove. Use due care when installing the valve cover and gasket to the engine ensuring not to bump the valve cover or drag it over top of the rocker arms causing the gasket to come out of the groove. Inspect the mating surfaces of the valve cover and cylinder head to ensure the valve cover gasket is installed properly. Failure to do so may result in an oil leak and/or an engine fire.

5. Install a new left or front valve cover gasket (1) into the new valve cover and make sure that the valve cover gasket is seated properly in the valve cover groove. The old valve cover is shown for illustrative purposes only.
 - 5.1. Install the six valve cover bolts and the six grommets into the valve cover.
 - 5.2. Apply medium strength thread lock compound (blue) to the six valve cover bolt threads.
 - 5.3. Install the NEW valve cover and gasket (1) to the cylinder head.
 - 5.4. Tighten the valve cover bolts to 10 Nm (89 lb in).
 - 5.5. Verify that the valve cover gasket is properly installed (see the warning above).
6. Install the 1-3-5 spark plug wires to the ignition coils.
