Subject: NHTSA Recall 09V-144 (Jaguar Recall Number J012) – 2004 Model Year Jaguar XJ vehicles for Under Floor and Rear Cross Member Brake Pipe Corrosion - Technical Bulletin

NUMBER J012 (Issue 1)

Safety RECALL: Under Floor Brake Pipe Corrosion

XJ (X350)

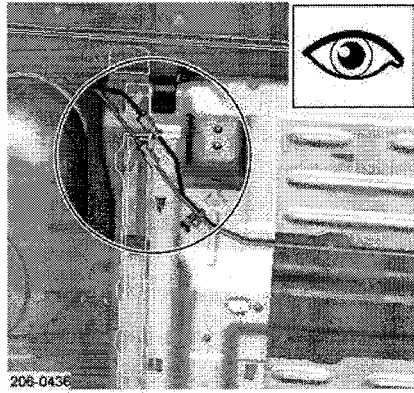
Figure 3

5. Inspect brake pipes for red rusting (Figure 3).

- If evidence of red rusting is present on any of the brake pipes, continue to **REPLACE UNDERFLOOR BRAKE PIPES**. (Figure 4)
- If no red rusting is evident proceed to step 6.

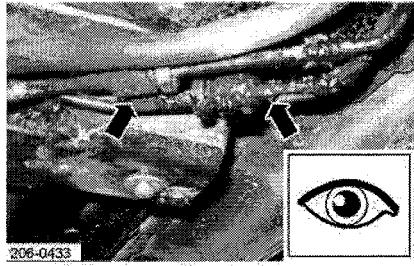
Figure 4

⚠ CAUTION: Red rusting indicates that the corrosion has begun to penetrate the steel inner pipe. (Figure 4)

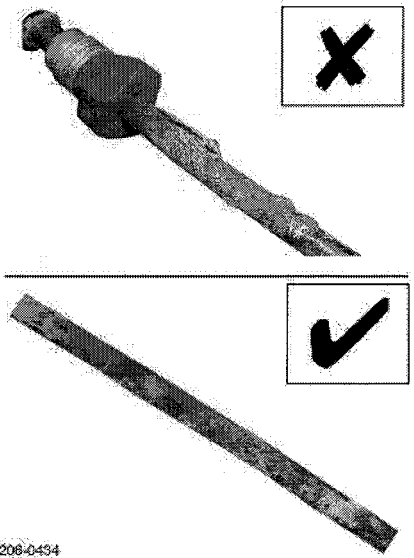
Figure 5

⚠ NOTE: White corrosion indicates zinc plating working correctly.

- If there is evidence of white corrosion but **NO** red rusting, no further action is required. Proceed to step 6. (Figure 5)

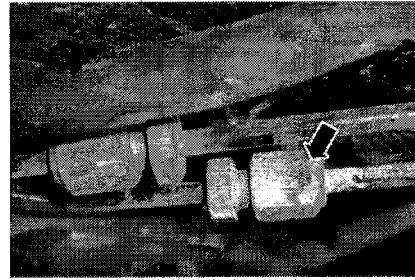
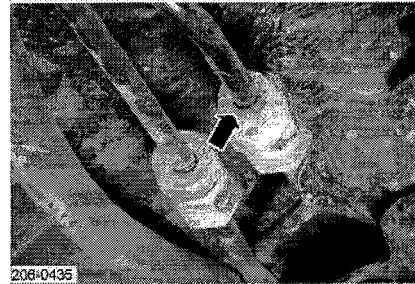
Figure 6

- If red rusting is present on the flat and front faces of the tube nuts **ONLY** (Figure 6), then the brake pipes are acceptable. Proceed to step 6
 - If the red rusting has progressed onto the brake pipe, proceed to **REPLACE UNDER FLOOR BRAKE PIPES** below.
6. Spray the brake pipes and unions with a suitable anti-corrosion spray.
 7. Install the RH undertray.
 - Install and tighten the rear bolts.
 8. Lower vehicle on ramp and return the vehicle to the customer.
