SERVICE BULLETIN		Date: 23rd June 2009 Model: Elise/Exige	CLASS 1	Number: 2009/01R USA Issue 2
	Service Manager	Service Reception	Supervisor		Parts Manager

NHTSA SAFETY RECALL

TITLE: Torque check of rear hub securing bolts on selected vehicles.

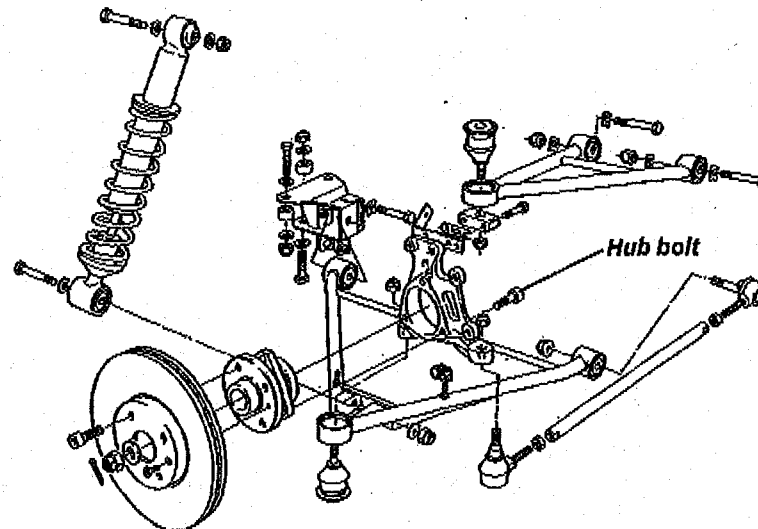
Note: The three hex. head bolts securing the hub bearing unit to the hub carrier are treated with Permabond A130 compound, and torque tightened to 90 Nm. In order to avoid breaking the adhesive bond, and the subsequent need for bolt removal, cleaning and adhesive re-application, the check procedure uses a lower torque setting in conjunction with witness marks.

1. Remove both rear roadwheels.
2. From the inboard side of the hub carrier, match mark the position of the three bolts securing the hub bearing unit to the hub carrier, by scribing a line across the head and onto the carrier.
3. Using a short torque wrench with 19mm crowsfoot adaptor ring, apply a 70 Nm tightening torque to each of the bolts in turn. If a suitable torque wrench or adaptor is not available, use a well fitting thin wall 19mm ring spanner, and apply full manual effort.
4. Examine the match marks to determine if any bolt movement has occurred;
 - If no; mark the bolt heads with white paint, and re-assemble (wheel bolt torque = 105 Nm).
 - if yes; before taking any further action, immediately inform Lotus Warranty by:
 Telephone: +44 (0)1953 608261
 E-mail: Warranty@LotusCars.co.uk
 If instructed to proceed:

- a) Remove the hub carrier from the car - see Service Notes sub-section DH.3.
- b) Thoroughly de-grease and clean the female threads in the hub carrier. Clean the thread of each bolt using a wire brush and Acetone, apply Permatbond A130 and re-Instal, tightening to 90 Nm.
- c) Mark the hub bolt heads with white paint.
- d) Reassemble the suspension - see Service Notes sub-section DH.3.
- e) Refit the roadwheels - wheel bolt torque = 105 Nm.
