# Newmar Corporation Warranty Department

TSB 363

**Subject:** Ground wire sizing for electric leveling jacks.

**Affected Units:** This recall is for specific isolated 2008-2009 All Star ME, 2008-2009 Ventana DP, 2009-2010 Dutch Star DP and 2008 Kountry Star DP.

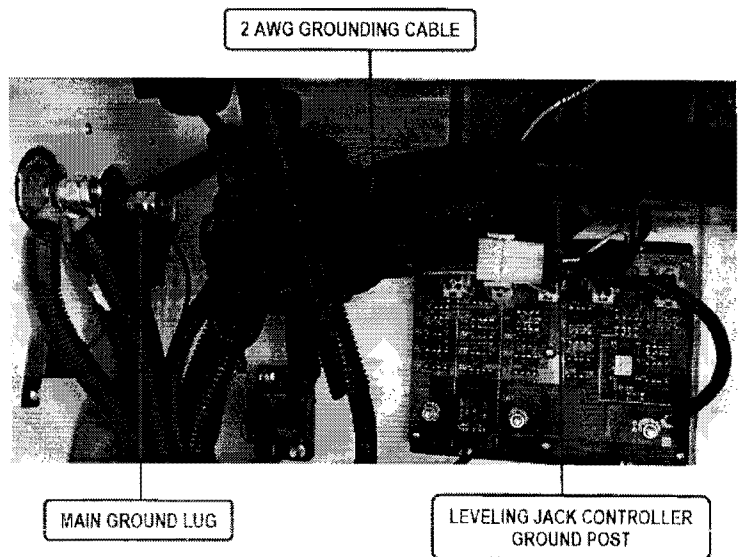
Figure 2

**Condition:** The ground wire for the electric leveling jack system is undersized. Undersized electrical conductors may result in conductor failure, creating a shock or fire hazard. Failure of the cable may occur without obvious preceding indicators.

- Measure length of 2 AWG cable required and cut to length. Strip cable ends and crimp ring terminals to cable.
- Attach small ring terminal of 2 AWG grounding cable to the ground post of the leveling jack controller (Figure 2) and large ring terminal to the main ground lug.
- Reset leveling jack controller per instructions in the owner's manual.

*Note 2: Torque conductive nut on the controller ground post to 20 – 20 in/lbs. Torque conductive nut on the main ground lug to 6 – 8 ft/lbs.*
