## EC Series Electrical System Mandatory Product Improvement

Trans/Air Manufacturing maintains a policy of continuous improvement of our products and services. In keeping with this philosophy, Trans/Air is issuing Mandatory Product Improvement 09-002, to address the following key areas of concerns in the aftermarket installation of Trans/Air EC series electrical Climate Control Systems.

Trans/Air has developed a product improvement kit p/n 5031234 for EC2.0 & EC2.5 and kit p/n 5031233 for EC3.0

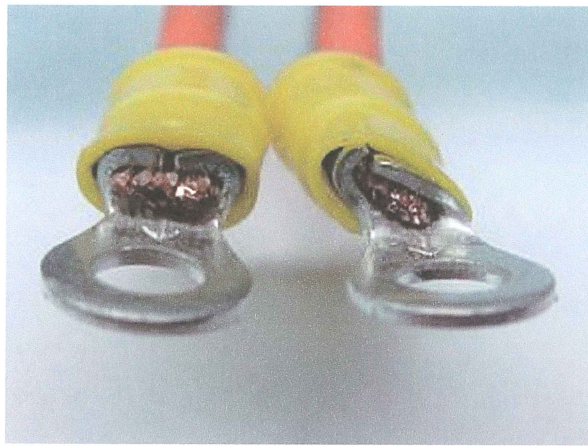
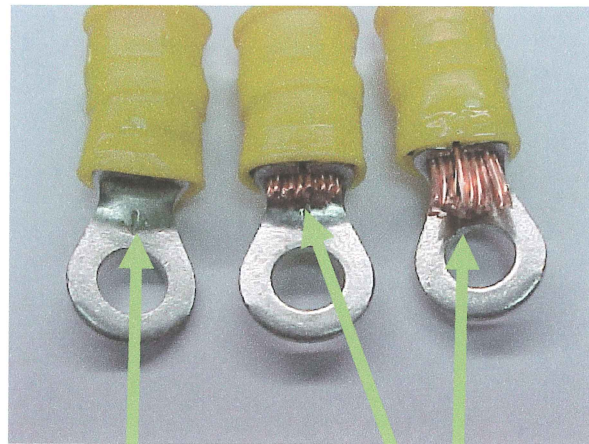
**Fig 1**

**Correct  
Position**

**Poor Position  
In Crimper**

**Correct**

**Poor  
Wire strands  
Too long**

1. Crimps on the wires going to the terminal strip of the relay board should be uniform and tight. There should be no bare wire visible between the wire insulation and the terminal, and strands flush with terminal barrel. (Fig 1 & Fig 2)

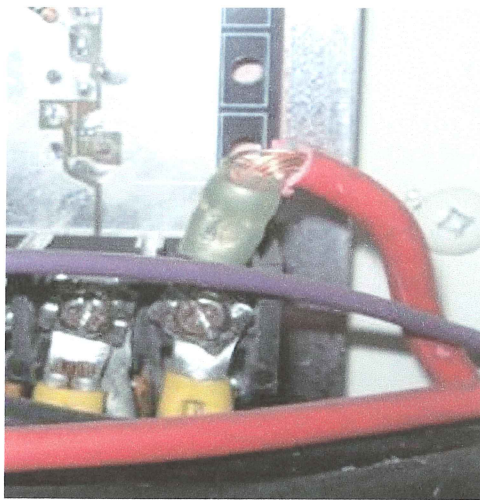
**Fig 2**

**Poor Crimp**

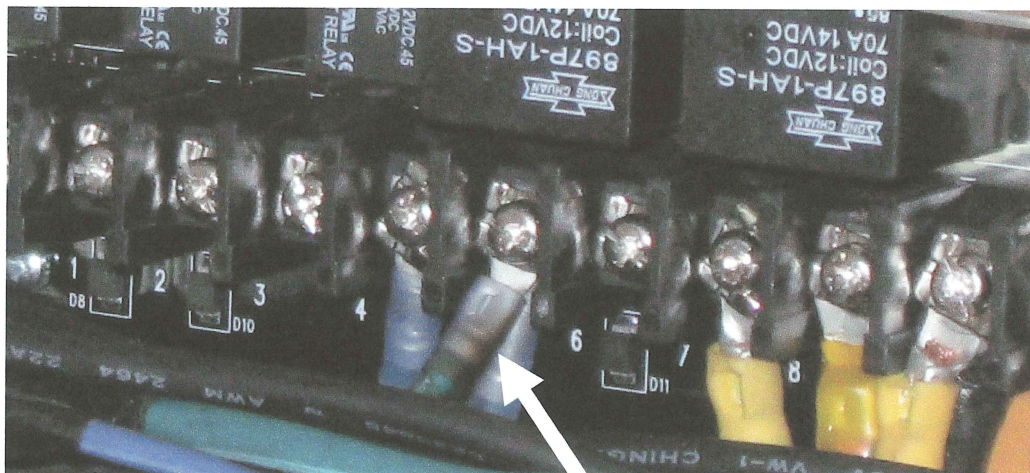
**Fig 4**

**Heat discoloration of a poor (loose) crimp**
