# Daimler Buses Recall Bulletin

NHTSA 09V-318/TC 09-240

## HEHR TIP-IN WINDOW STOPS RECALL NOTICE

SAFETY DEFECT - Hehr Tip-in Window Stops.

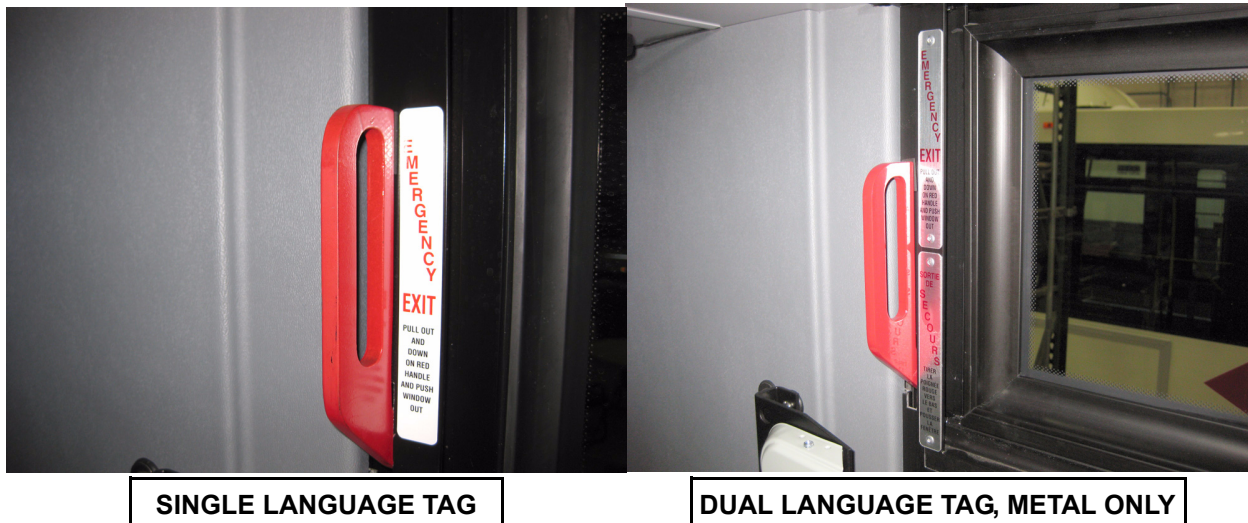
**Figure 1-1 Egress Window Language Tags**

In order to install tip-in window stops, certain upper deck dual language emergency labels will need to be revised. Single Language tags are not affected.

1. Inspect the upper deck egress windows for single or dual language tags:
  - a. If upper deck egress window has a single language tag, proceed to [“Single Language Upper Deck Egress Window” on page 10.](#)
  - b. If egress window has a metal dual language tag, proceed to [“Dual Language Upper Deck Egress Window” on page 5](#)
