RECALL BULLETIN 09V-337

DATE: October 5, 2009
 MODEL YEAR: 2007 & 2008
 CHASSIS MODEL: UD3300 with Locally Installed DUAL STEERING
 BULLETIN NUMBER: 09V-337

VOLUNTARY SAFETY RECALL CAMPAIGN NUMBER 09V-337 STEERING STOP ADJUSTMENT

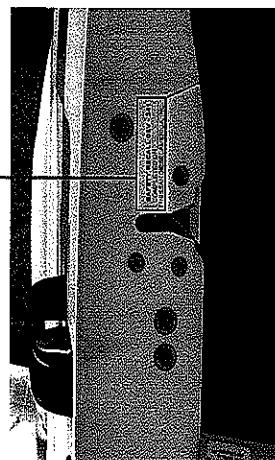
Figure A

- If the involved vehicle has a label on the inside of the driver's left door as shown in Figure A, the recall has already been performed and no further action is required.
- If the involved vehicle does not have the label on the inside of the driver's door, verify through the Vehicle Service Notification screen of the NDAINET system that the recall is required. Complete the safety recall according to the following instructions.

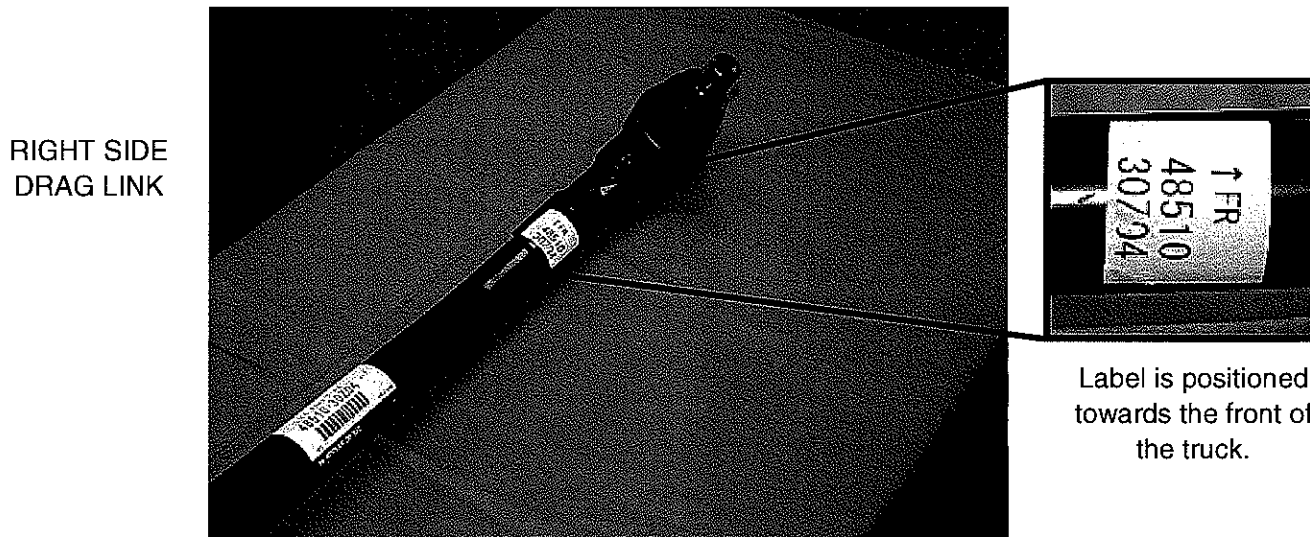
Figure B

- A) The drag link should be installed with the directional arrow and part number label facing the front of the truck. The label may be covered with road dirt and the arrow not visible. The drag link is installed correctly if the label is positioned towards the front of the truck and steering gear. See figure B.

- B) If the drag link is installed correctly proceed to step 2.
- C) If the drag link is installed incorrectly remove the drag link and reinstall in the correct direction as shown in Figure B. Torque the nuts to 159 -253 lb.ft. and install the cotter keys.
- D) If the drag link has been damaged by contact with the tire, install a new drag link part number **4851030Z04**.
- E) Install the new drag link with the directional arrow facing the front of the truck. Torque the drag link nuts 159 -253 lb.ft. and install the cotter keys.
