Service Bulletin No. 331B

MODEL D4500 / D4505 Series Coaches	TYPE Field Change Program	SECTION/GROUP 12--Suspension	DATE Sept. 11, 2009
SUBJECT TAG AXLE TIE ROD LOCK CLAMPS REPLACEMENT			
CONDITIONS

Ref. NHTSA Recall No.: 09V-350

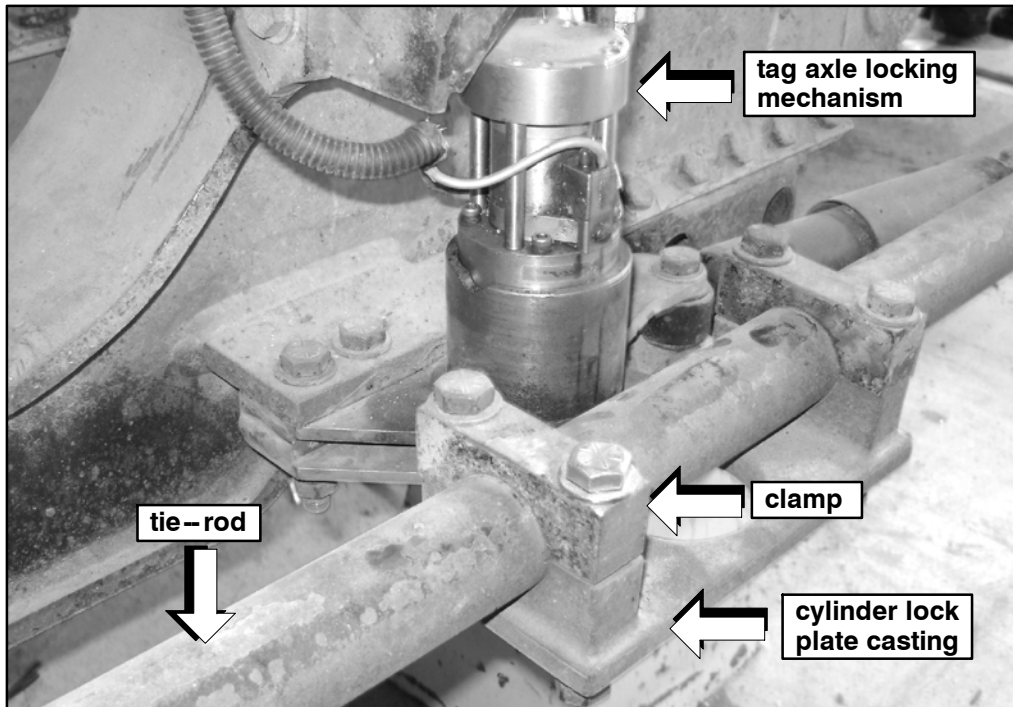
Figure 2.

5. Locate the tag axle locking mechanism (refer to Figure 2).

6. Using a clean cloth, remove any dirt or grease from the tie rod and clamps (refer to Figure 2).
Visually inspect the tie rod for scuff or drag marks indicating that the tie rod has moved within the lock clamps.

Upon inspection, if scuff or drag marks are present indicating tie rod movement within the lock clamps, loosen the clamp hardware and re-orientate the tie rod / clamp relationship by aligning the beginning of the scuff marks on the tie rod with the edge of the applicable clamp.

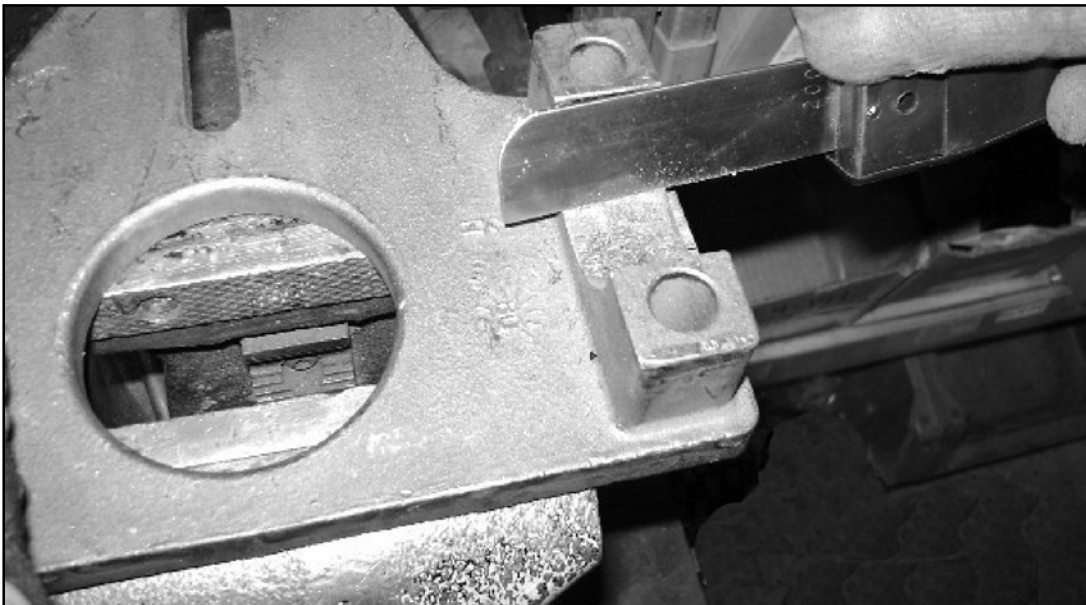
The cause of the defect is insufficient clamping force, due to paint on the clamping surfaces, between the tie rod and the cylinder locking plate on the tie rod with the Meritor FH 946 14000 lb. rated tag axle. This allowed relative movement of the cylinder locking plate on the tie rod, which resulted in the tag steering system either not automatically locking above approximately 20 MPH, or locking with the tag wheels not in a straight-ahead position.

Figure 5. Reference photo.

10. Using a scraper and cloth, remove all traces of graphite coating, paint and grease from the cylinder lock plate casting and the tie rod (refer to Figure 5).

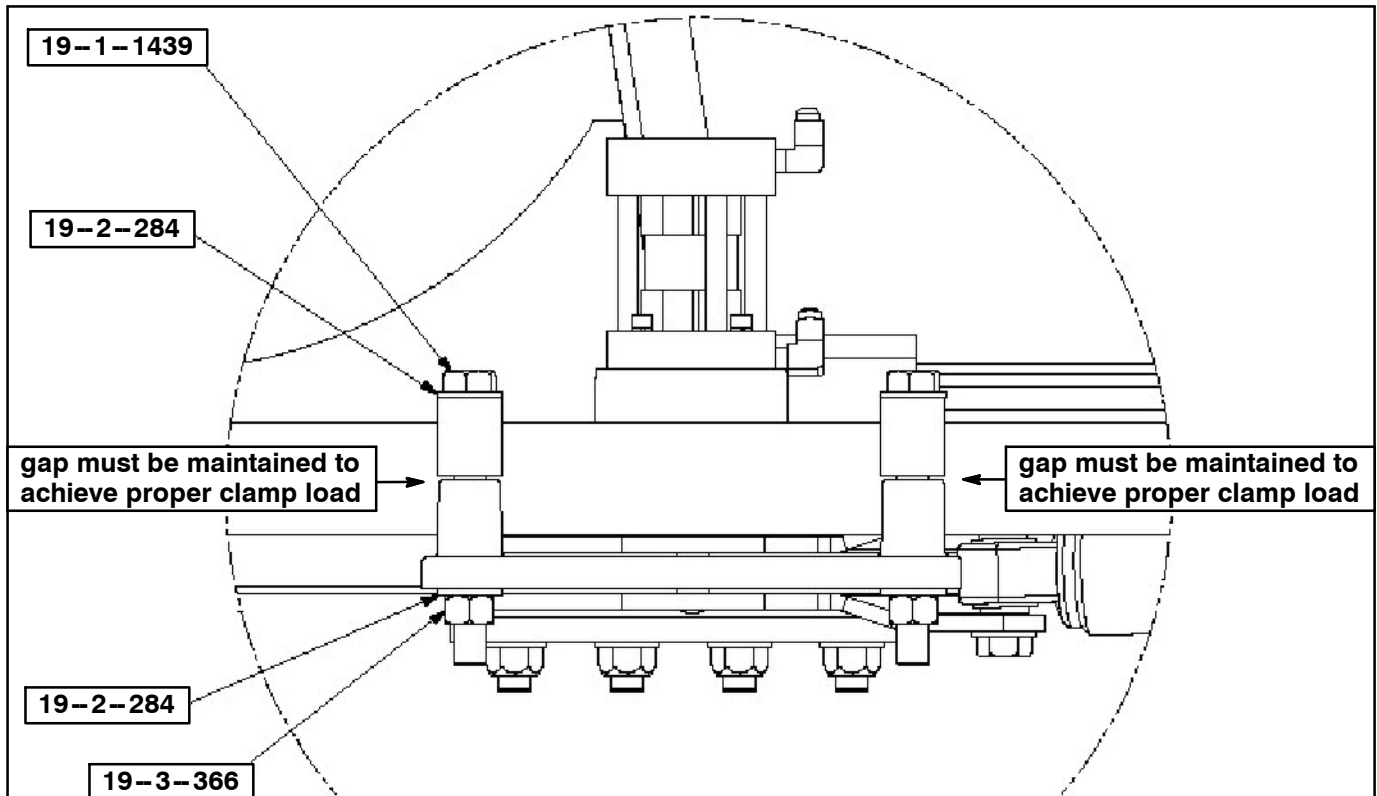
Figure 6.

To achieve proper clamp load, the gap must be maintained between the upper and lower clamps (refer to Figure 6).

11. Re-assemble lock casting into the lock cylinder plate (refer to Step 9.).
12. Apply loctite, p/n 21-7512-5, to the threads of the capscrews, p/n 19-1-1439.
13. Using the new hardware provided, align and install new clamps, p/n 12-04-1153, in between the masking on the tie rod (refer to Figures 3 and 6).
14. Line up the lock plate with the lock cylinder. Snug up all bolts to secure the clamps in position.
15. Turn coach ignition to the OFF position, locking the cylinder into the plate.

16. Torque the lock cylinder plate capscrews to 85–90 lbs.-ft. Torque nut, p/n 19-3-366, to 70–80 lbs.-ft.
