Safety Defect and Noncompliance Report Guide for Equipment
PART 573 Defect and Noncompliance Report¹

Generic name of the item: Aftermarket Steering Pitman Arm AKA "Pitman Arm"

Part Number: Fabtech- FTS93001, FT44039 **Size:** 2" x 8"

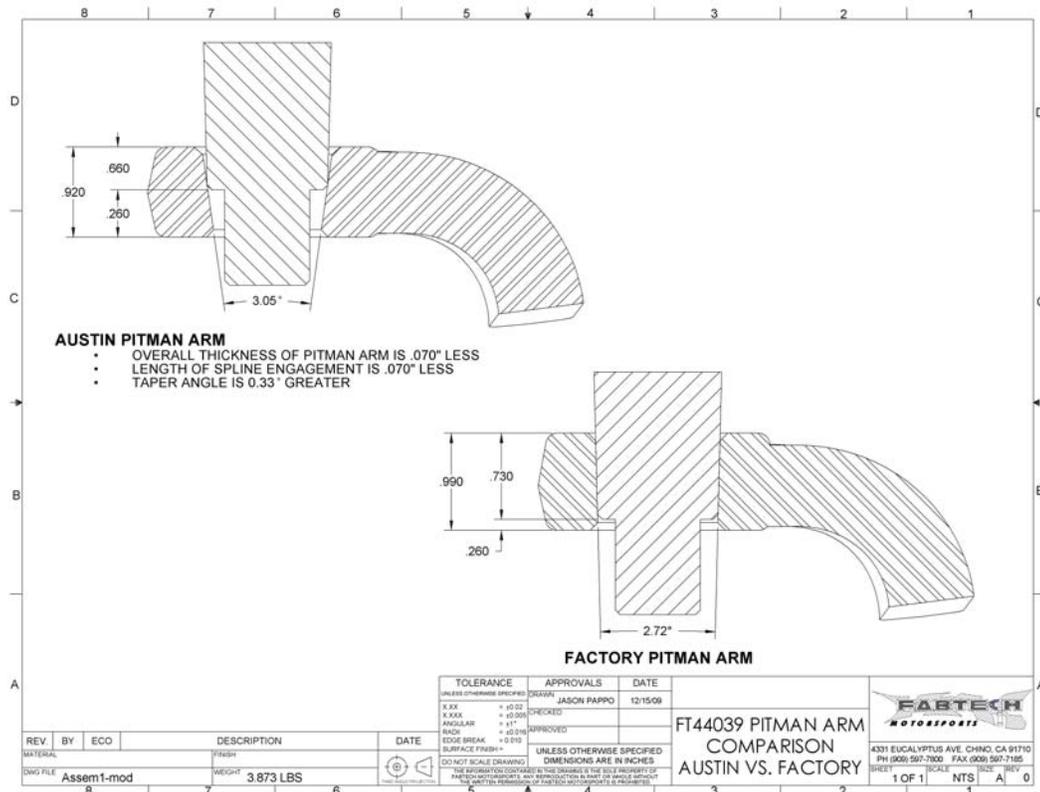
The defective part is commonly known as the Pitman Arm. This steering component is a forged arm with two holes in it. One end of the arm is splined and attaches to the steering box sector shaft of the vehicle. The other end is a tapered hole that allows the connection of the steering drag linkage to attach. The drag linkage connects to a tie rod that steers the vehicles wheels. Certain pitman arms may not have the correct tapered angle in the splined hole to mate to the steering box sector shaft. When the spline taper is different it can allow the pitman arm to move back and forth on the sector shaft. This creates spline wear and eventually causes cracking and finally breaks away. Once broken off there is no other component connecting the steering box to the front wheels of the vehicle, resulting in total steering loss. wing.

The pitman arm splined hole must be the same tapered angle as the steering box sector shaft. This results in both surfaces mating together the by the overall length of the spline on each part. If the taper angle is not the same the splines will not be full mated / engaged together. This leaves only partial engagement of the splines. Thereby reducing the usable surface area of the two parts together. With less surface area and incorrect taper angle the pitman arm will start to wear due to the lack of engagement. Once wear begins to take place fractures occur and finally a breakage. Separating the steering box from the vehicle's wheels. See below drawing of tapered spline comparison of Austin pitman arm to factory pitman arm.

After evaluating all test data Fabtech established the theory of failure was due to 1/20/2010
the dimensional differences between the Austin and OEM pitman arms. Fabtech measured each part using a coordinated measuring machine (CMM) and found that there was a significant difference in the length of spline engagement as well as the taper angle. This condition would cause the pitman arm to rock back and forth creating an abnormally large stress riser at the spline causing material failure in the area at or near the spline. Fabtech adopted this theory as fact and contacted Austin to initiate a voluntary recall of all of the Dodge Pitman Arms supplied to Fabtech.

Remedy- Once a vehicle has been identified that it has one of our Pitman Arms with a raised casting number on the pitman arm we are instructing the following. End consumer is to take vehicle to a Fabtech Authorized Installer for an inspection and retro fit process immediately. The Authorized Installer will remove the original Fabtech parts and replace them with new Fabtech pitman arm free of charge. The original parts are to be returned to Fabtech for inspection and identification. Once Fabtech has processed the returned pitman arm they will issue a check for the labor of the retro fit of the pitman arms to the Authorized Installer. Fabtech will log all retro fit processes and contact each end consumer directly to make sure that their vehicle has been retro fitted properly. Fabtech has created extensive written procedures on how to inspect and process an end consumer's vehicle. Fabtech can provide these documents upon request by NHTSA.

The remedy pitman arm can be identified by raised casting numbers on the face of the arm. The pitman arm that will be removed does not have any raised casting numbers on the arm.
