10V-053
(3 Pages)

Re: Defect Information Report FL-572, Pitman Arm Installation

Defect Information Report

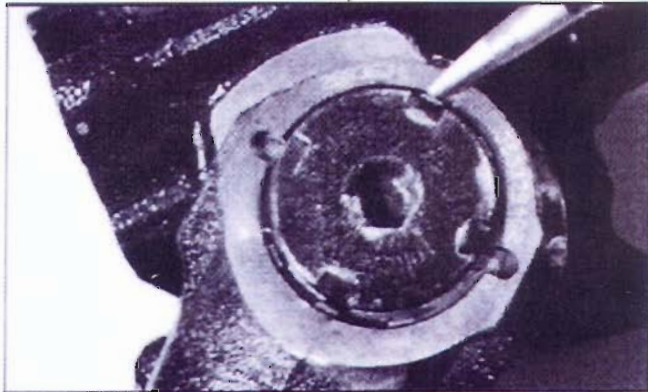
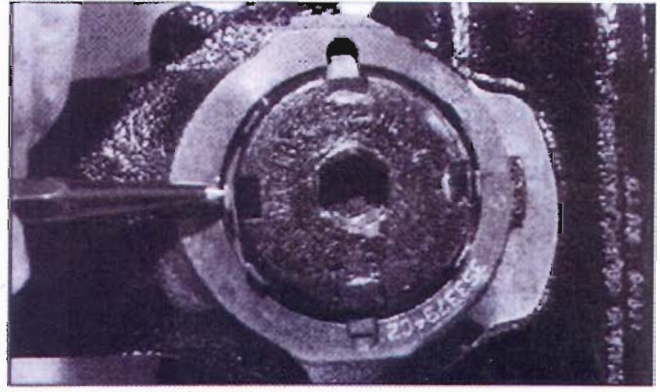
(c)(5) Description of the defect: Restraining washer locking tabs may not have been seated into the pitman arm retainer notches during assembly at the Saltillo plant.

Restraining washer tabs shown aligned with notches in retainer prior to bending

49CFR Section 577.5(f) Evaluation of the risk to motor vehicle safety: Incomplete installation of the pitman arm retaining mechanism may allow unthreading of the retainer, and in the worst case, disengagement of pitman arm from the steering box resulting in loss of steering and crash.

- (c)(7) **Noncompliance-test or other data:** Not Applicable
- (c)(8) **(i) Remedial program:** Potentially affected vehicles will be inspected to insure pitman arm retainer is properly torqued and restraining washer is properly installed with locking tabs seated in notches of the retainer. Repairs will be performed by Daimler Trucks North America dealerships and Direct Warranty customers, i.e., customers approved by Daimler Trucks North America to do their own warranty repairs
Reimbursement Plan: Copies will be submitted as a supplemental report when available.
