Safety Defect and Noncompliance Report Guide for Vehicles  
**PART 573 Defect and Noncompliance Responsibility and Reports**<sup>1</sup>

Make(s): SUTPHEN Model Years Involved: '04-'07 Model(s): SPH

## Pre 2007: S-60 Driveline Modification

SPH Driveline Campaign

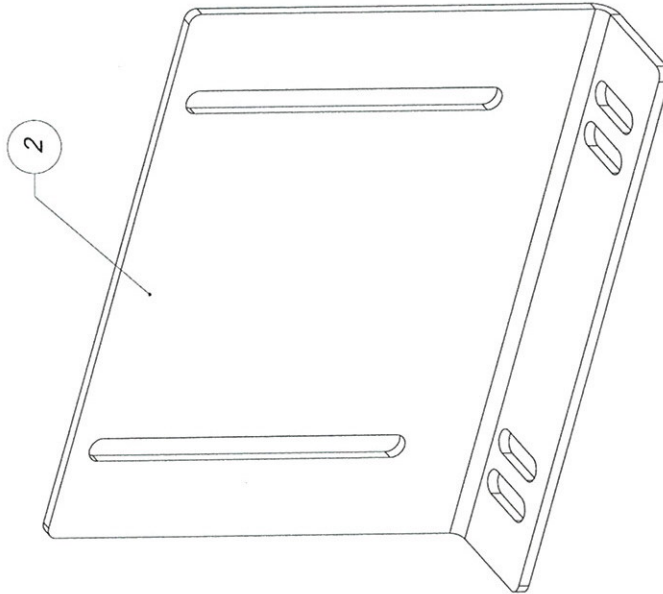
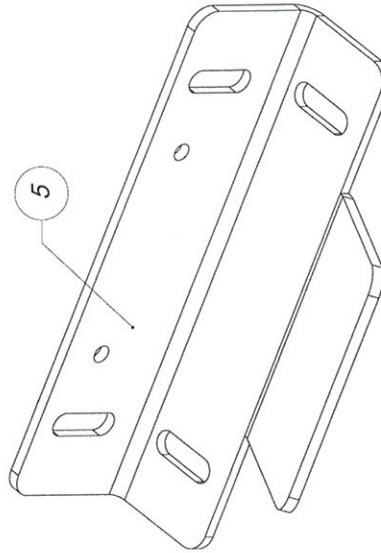
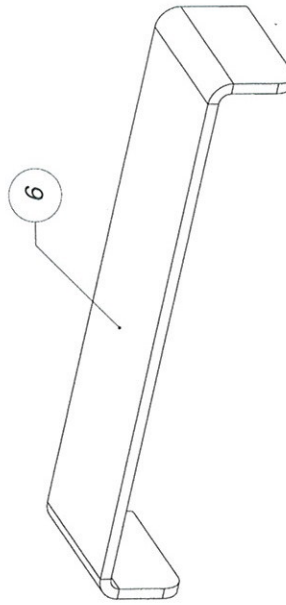
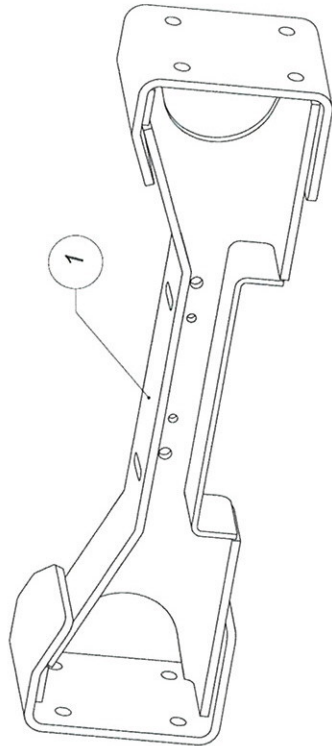
PARTS LIST, AERIAL DRIVE DRIVELINE CORRECTION	
DRAWN BY	J. HAULMAN
DATE	2/09/10
NEXT ASSEMBLY	JNH 3241
FINISH	BY ECN
PER DETAILS	
CHF-2718	
HEIGHT (US)	
SHEET	
1 OF 1

Drive line Angles out of tolerance. Engines mounted low with respect to carrier bearings and pump gear boxes caused the non compliance. 1<sup>st</sup> and 2<sup>nd</sup> Drive shafts

Engines mounted low with respect to carrier bearings and pump gear boxes caused the non compliance.

Vibration in the Drive line  
Premature Failure of U-Joints

Pre 2007 w/Detroit Diesel 5-60: Modified X-member will Allow Drive line Angles to be within Tolerance. See Attached Description AND CHF-2718 For Details

Pre 2007: Modified X-member is notched (See CHF-2718)

Production was corrected by providing every CHASSIS with A NOTCHED X-member similar to CHF-2718 so ALL Drive line Angles would be in tolerance. Change was implemented JANUARY 15<sup>th</sup> 2010.

- 6) Cut out and modify front cross member per drawing #CHF-2582 by welding in part #CHF-2582-01 drilling two 9/16" holes and grinding welds appropriately.

MODIFIED CHF-424 CROSS MEMBER PER CHF-2582 DRAWING
