10V-108
(4 pages)

RE: Part 573 Defect Information Report – 2010 Subaru Tribeca Door Latch Unintentional Disengagement

Defect Information Report (49 CFR Part 573.6)

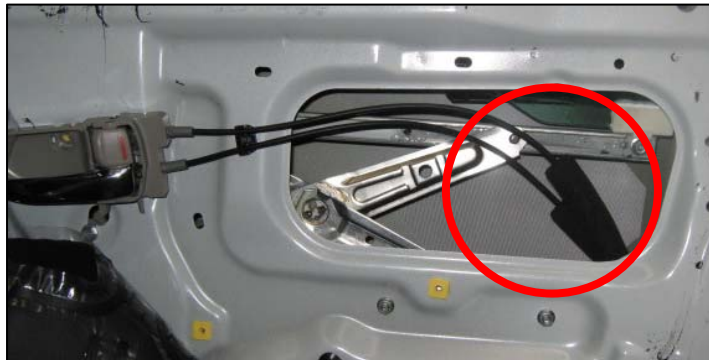
- (1) A technical report that FHI received from another market indicated the following:
While a customer drove the car, passenger-side front door opened unintentionally as the door latch was disengaged during door glass operation upward.
- (2) Production change giving rise to the problem:
In 2010MY Tribeca production at SIA (Subaru-Indiana Automotive, Inc.) in the U.S.A., an insulator foam for vibration prevention was additionally installed to each of inner remote door handle and lock cables as the new audio system was introduced. Also, the inner remote door handle cable routing was changed to be closer to the door glass at the same time.
- (3) Cause of the Defect
The two foam pads overlapped each other at a certain location within the regulator movement range, which resulted in insufficient gap between inner remote door handle cable and regulator which causes an interference.
