10V-110
(12 Pages)

Re: Recall of Braun manufactured handicapped accessible mobility vehicles
Ref. NHTSA Campaign Number:

Safety Recall Notice Service Bulletin 36144

Trailing Arm Inspection and Reinforcement
Plate Retrofit Instructions
Applicable for 2005-2008 GM Entervan®
Lowered Floor Conversions

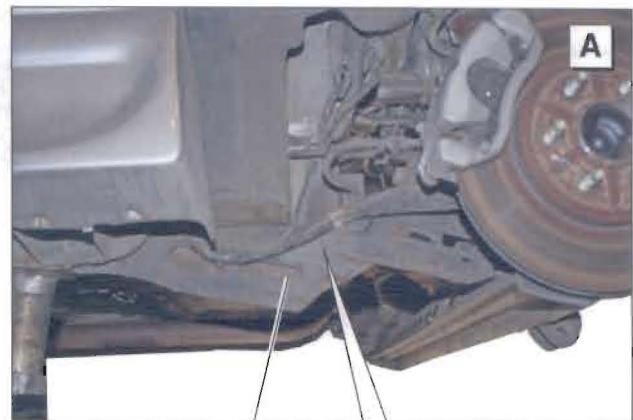
Ensure the presence of the weld and verify the weld is free of cracks.

Trailing Arm
Inspect this Weld

If the weld is present and free of cracks, no further action is required. Apply undercoating and install rear wheel.

If the weld is missing or cracked proceed to Step 3.

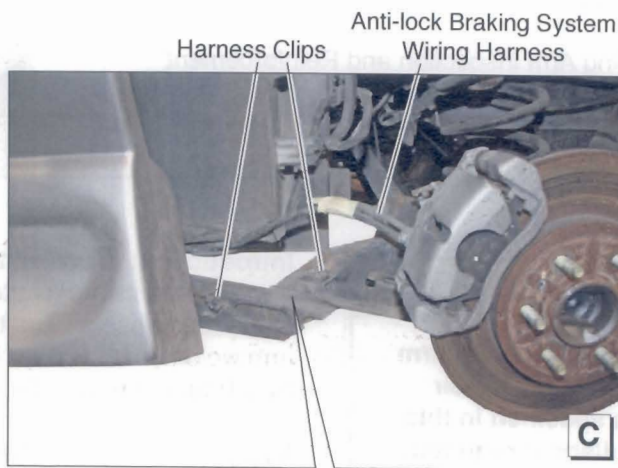
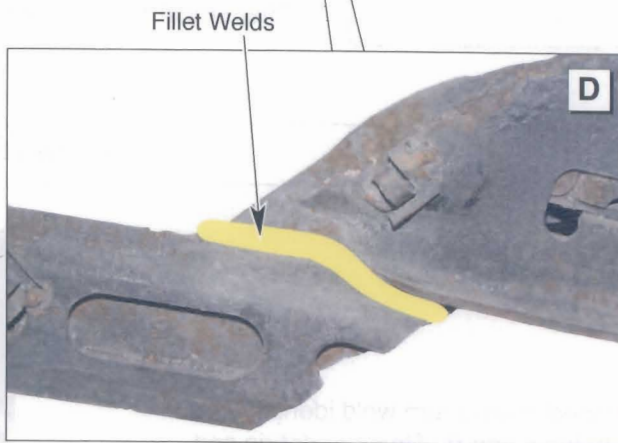
Weld Highlighted in Yellow

4. Remove anti-lock braking system wiring harness from securement clips and secure harness clear of the trailing arm. See Photo C.

Remove under coating and seam sealer from the weld areas. Remove questionable weld(s). Ensure surfaces to be welded are free of weld slag and grinding debris.

5. Apply penetrating fillet welds along the edges of brackets as shown in Photo D.

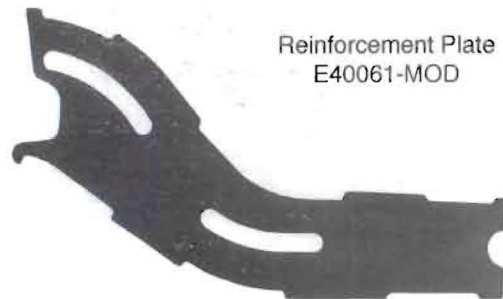
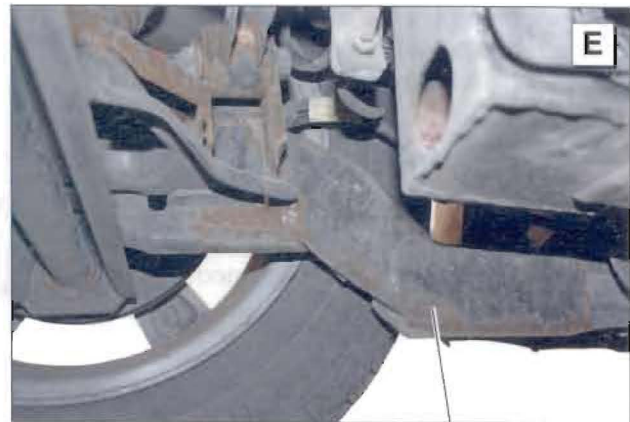
Inside of
Trailing Arm

6. Clean surface on inside of trailing arm (remove any debris, undercoating, or rust). See Photo E.

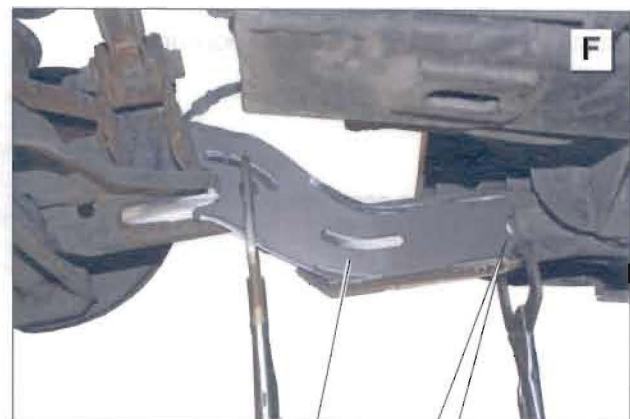
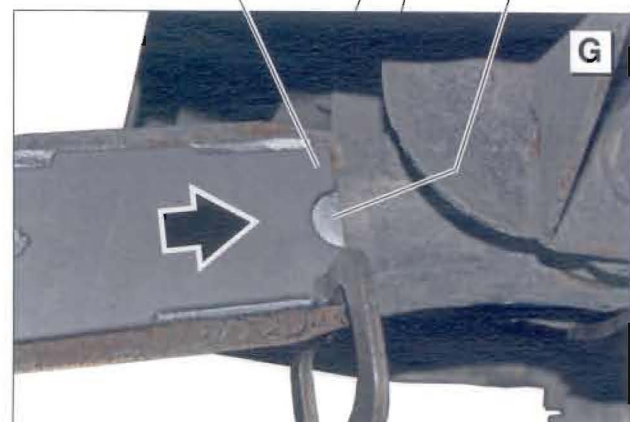
Reinforcement
Plate

Reinforcement Plate
Forward End

Trailing Arm
Forward End

7. Center reinforcement plate on inside of trailing arm with the forward end of reinforcement plate flush with forward end of trailing arm. See Photos F and G.
