Safety Defect and Noncompliance Report Guide for Vehicles
AMENDED PART 573 Defect and Noncompliance Report

MCI Service Bulletin 344

All E model and J model coaches equipped with a DOGA windshield wiper motor.

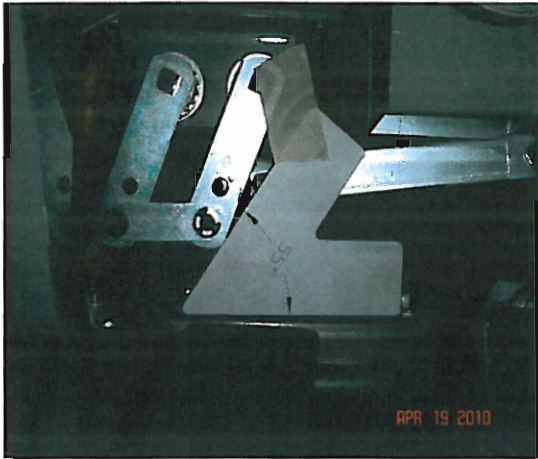
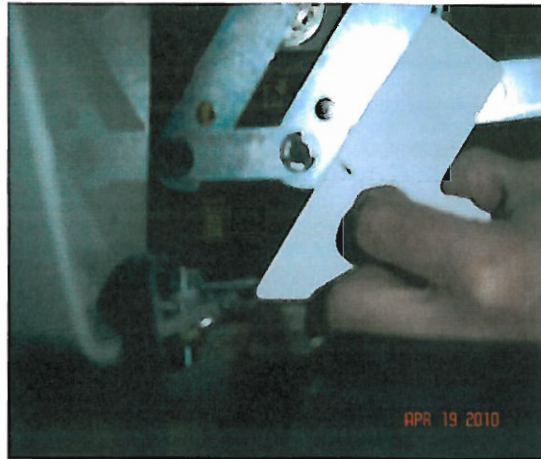
Second, DOGA has found the wiper system linkages that connect the drive motor to the wiper arms may be assembled incorrectly. The force required to move a wiper arm with such incorrectly-assembled linkages is higher than DOGA anticipated, and causes a higher load input to the motor and premature damage to the motor.

Curb side wiper arms, before and after adjustment.

Adjustment to the main wiper linkages is required so that the arm swing angle from the wiper arm pivot is 35 degrees on both sides vertical, which provides the optimal torque on the motor. Using an adjustment gage, the angle measured from the frame member is 55 degrees as shown.

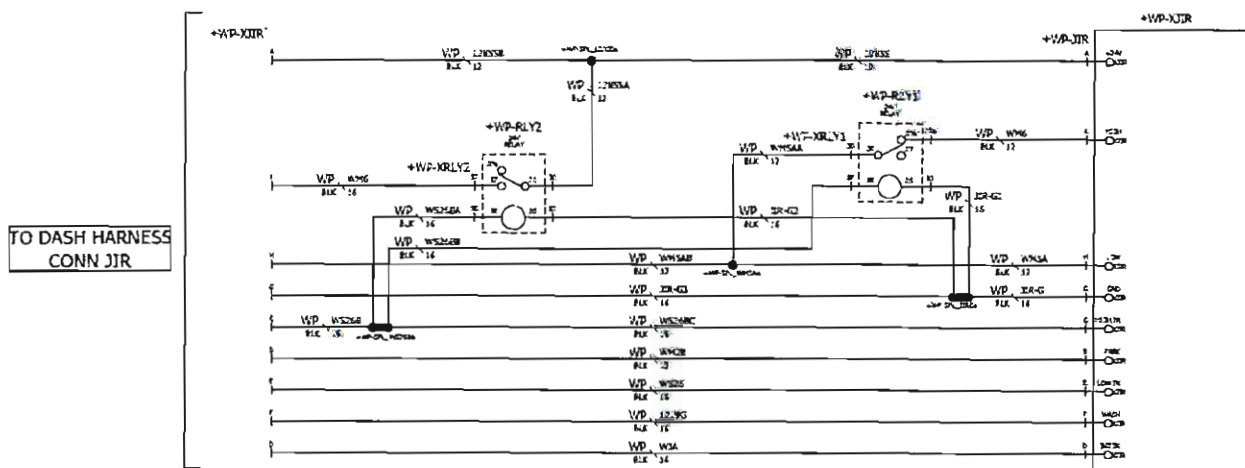
Schematic of by-pass harness

First, the wiper controller that controls the intermittent mode of the wiper system may switch the wiper motor into its high speed mode when the wiper system is under heavy load, such as when operating in high wind, heavy rain, or dry windshield conditions. This switching occurs as a result of the thermal protection system that is integral to the design of the controller. DOGA has found that this switching occurs at a much higher rate of occurrence than DOGA anticipated, and as a consequence is causing premature damage to the motor.

2. Add a by-pass harness to by-pass high speed output of the wiper controller. Reduces the amount of time the wiper motor operates in high speed.

The by-pass harness interfaces between the wiper switch in the steering column, the wiper controller and the wiper motor. The harness is installed by disconnecting the plug to the wiper control module and installing it. This harness prevents the wiper controller from operating the wiper motor in high speed mode in the event of increased current draw. The high speed operation is powered through a relay controlled by the column switch. The harness also prevents the activation of both the high speed and low speed function of the motor at the same time.
