RE: Defect Notification Report for the Model Year 2010 Porsche Panamera Models

PART 573 Defect and Noncompliance Report

Recall campaign AA01 - Fitting additional locking element on belt anchoring system for front seats

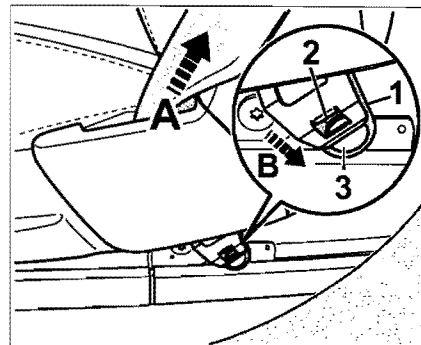
To do this, pull on the seat belt (⇒ Figure 1 -arrow A-).

The seat belt mount (⇒ Figure 1 -item 1-) must be anchored at the front seat and must become locked with the safety clip (⇒ Figure 1 -item 2-) at the abutment head of the belt anchoring system (⇒ Figure 1 -item 3-) when the seat belt mount is moved in direction of arrow (⇒ Figure 1 -arrow B-).

Anchor the seat belt mount correctly at the front seat if necessary and move it into the position shown in ⇒ Figure 1 .

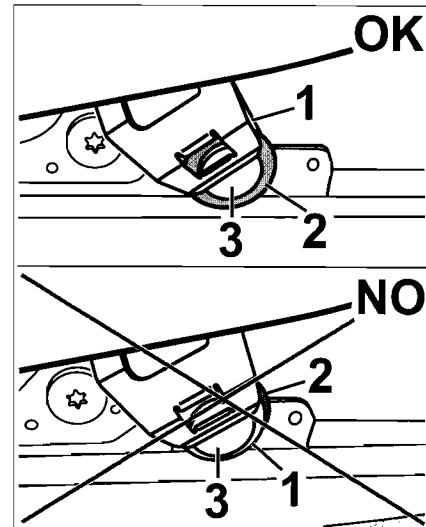
Figure 2

The correct position of the locking element is shown in ⇒ *Figure 2 -top-* and ⇒ *Figure 3 -top-* using the **left front seat** as an example.

- Item 1: Seat belt mount
- Item 2: Locking element
- Item 3: Abutment head of belt anchoring system

The additional locking element must be fitted between the abutment head of the belt anchoring system and the seat belt mount.

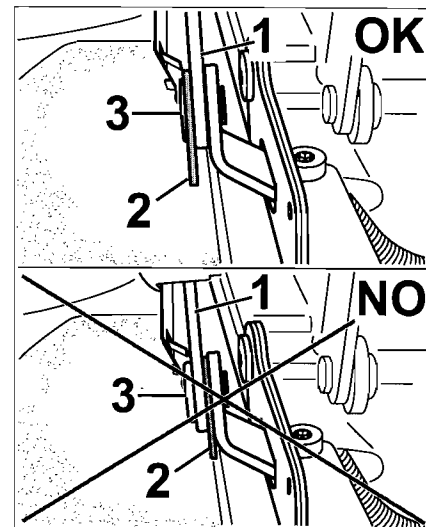
Figure 3

⇒ *Figure 3* shows the belt anchoring system on the **left front seat** from the perspective “looking onto the seat rail of the front seat from the rear footwell”.
