Safety Defect and Noncompliance Report Guide for Vehicles
AMENDED PART 573 Defect and Noncompliance Report

On March 24, 2010, Motor Coach Industries, Inc. decided that a defect which relates to motor vehicle safety exists in the motor vehicles listed below, and is furnishing notification to the National Highway Traffic Safety Administration in accordance with 49 CFR Part 573 Defect and Noncompliance Reports.

MCI Service Bulletin 344

All E model and J model coaches equipped with a DOGA windshield wiper motor.

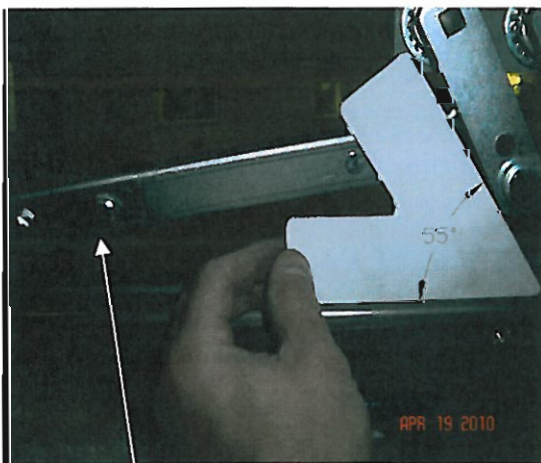
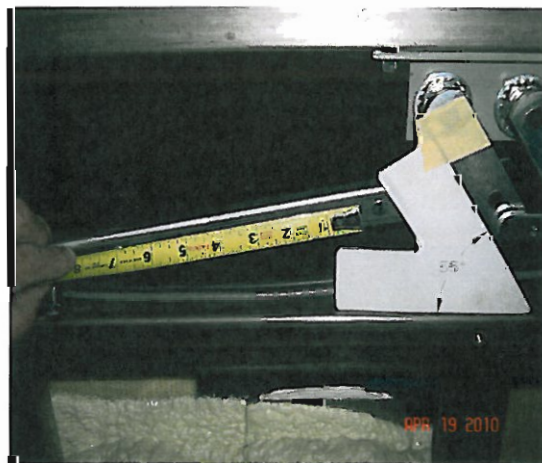
Second, DOGA has found the wiper system linkages that connect the drive motor to the wiper arms may be assembled incorrectly. The force required to move a wiper arm with such incorrectly-assembled linkages is higher than DOGA anticipated, and causes a higher load input to the motor and premature damage to the motor.

Road side wiper arms, before and after adjustment.

Adjustment to the main wiper linkages is required so that the arm swing angle from the wiper arm pivot is 35 degrees on both sides vertical, which provides the optimal torque on the motor. Using an adjustment gage, the angle measured from the frame member is 55 degrees as shown.

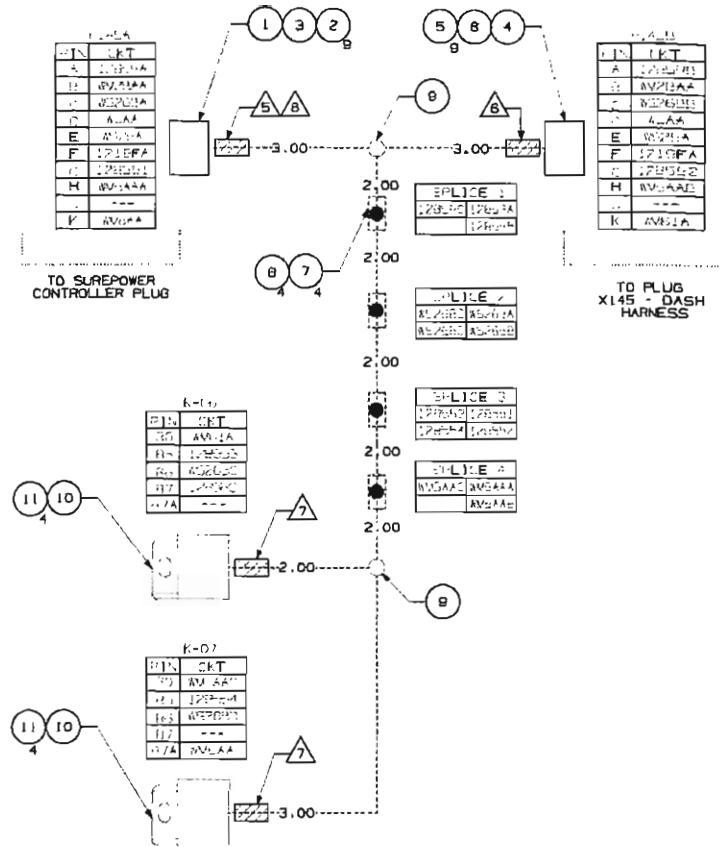
By-pass harness

First, the wiper controller that controls the intermittent mode of the wiper system may switch the wiper motor into its high speed mode when the wiper system is under heavy load, such as when operating in high wind, heavy rain, or dry windshield conditions. This switching occurs as a result of the thermal protection system that is integral to the design of the controller. DOGA has found that this switching occurs at a much higher rate of occurrence than DOGA anticipated, and as a consequence is causing premature damage to the motor.

1. Set the linkages of the arms to the recommended angle of 35 degrees from vertical as shown in the following photographs.
2. Install a bypass harness on the controller that prevents the controller from switching the motor to high speed. A schematic of this bypass harness is shown below.
3. Install a new DOGA model 259 motor in place of the model 258 motor. The 259 motor has a higher load capacity than the current 258 motor, which is intended to provide an additional safety margin to the wiper system.
