10V-196
(4 pages) Amended

RE: Part 573 Defect Information Report – Crack of CVT Fluid Cooler Hose on 2010 Subaru Legacy & Outback-Compete Submission

Defect Information Report (49 CFR Part 573.6)

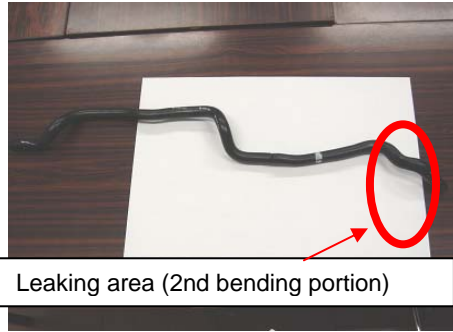
(1) A technical report that FHI received from other markets indicated fluid leak from CVT fluid cooler hose and MIL illumination.

(2) Production change produced the problem:

- a) Length of rubber hose was set up 16mm longer for a specific time, i.e. between 7th of August, '09 and 10th of September, '09.
- b) An additional new associate worked the hose insertion to mandrel (shaft to process hose) with 3 experienced workers between 23rd of June, '09 and 31st of August, '09.

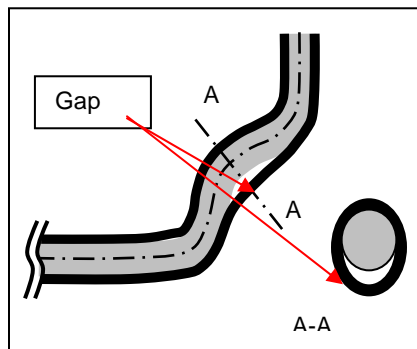
(3) Cause of the Defect

A gap between the hose and mandrel became larger than usual when the longer hose was inserted to mandrel with excessive force.

- a) Under these circumstances, if the split area was gripped tightly during hose insertion, the outer surface of the hose collapsed and folding ripples are generated on the internal hose.
- b) A split developed from the starting point of internal folding ripples generated by collapse of the hose to outer surface of the hose during internal pressure, which resulted in a large fluid leak. If the fluid is completely leaked during driving, the vehicle will come to a stop.

The remedy plan calls for dealers to check lot number of the fluid cooler hose. The hose will be replaced with a new one if the lot number shown is in the effected range.
