10V-196
(4 pages) Amended

RE: Part 573 Defect Information Report – Crack of CVT Fluid Cooler Hose on 2010 Subaru Legacy & Outback-Compete Submission

Defect Information Report (49 CFR Part 573.6)

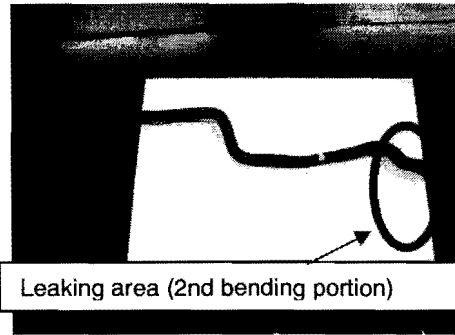
(1) A technical report that FHI received from other markets indicated fluid leak from CVT fluid cooler hose and MIL illumination.

- a) Length of rubber hose was set up 16mm longer for a specific time, i.e. between 7th of August, '09 and 10th of September, '09.
- b) An additional new associate worked the hose insertion to mandrel (shaft to process hose) with 3 experienced workers between 23rd of June, '09 and 31st of August, '09.

The remedy plan calls for dealers to check lot number of the fluid cooler hose. The hose will be replaced with a new one if the lot number shown is in the effected range.

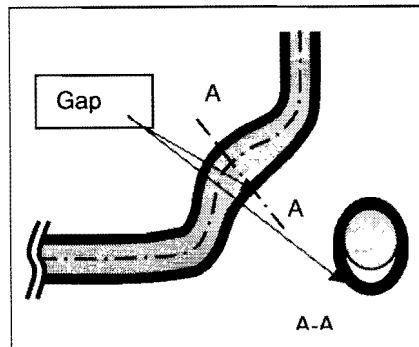
A gap between the hose and mandrel became larger than usual when the longer hose was inserted to mandrel with excessive force.

- a) Under these circumstances, if the split area was gripped tightly during hose insertion, the outer surface of the hose collapsed and folding ripples are generated on the internal hose.
- b) A split developed from the starting point of internal folding ripples generated by collapse of the hose to outer surface of the hose during internal pressure, which resulted in a fluid leak.
