10V-196

**RE: Part 573 Defect Information Report – Crack of CVT Fluid Cooler Hose on 2010 Subaru Legacy & Outback**

## Defect Information Report (49 CFR Part 573.6)

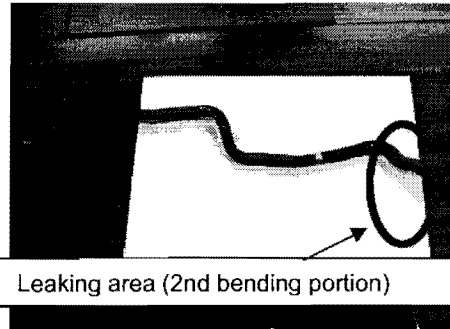
(1) A technical report that FHI received from other markets indicated fluid leak from CVT fluid cooler hose and MIL illumination.

A gap between the hose and mandrel became larger than usual when the longer hose was inserted to mandrel with excessive force.

- a) Under these circumstances, if the split area was gripped tightly during hose insertion, the outer surface of the hose collapsed and folding ripples are generated on the internal hose.
- b) A split developed from the starting point of internal folding ripples generated by collapse of the hose to outer surface of the hose during internal pressure, which resulted in a fluid leak.

The remedy plan calls for dealers to check lot number of the fluid cooler hose. The hose will be replaced with a new one if the lot number shown is in the effected range.
