**Re: PART 573 NOTICE RE ARVINMERITOR ADAPTER PLATE BOLT TORQUE**  
**(10E-014)**

Safety Defect and Noncompliance Report Guide for Vehicles  
**PART 573 Defect and Noncompliance Report**

Re: Defect Information Report, in accordance with 49 CFR §573.6, concerning certain front and tag axles shipped to ArvinMeritor customers between August 10, 2009 and April 6, 2010.

**NOTICE:** Defect Information Report, in accordance with 49 CFR §573.6, concerning certain front and tag axles shipped to ArvinMeritor customers between August 10, 2009 and April 6, 2010.

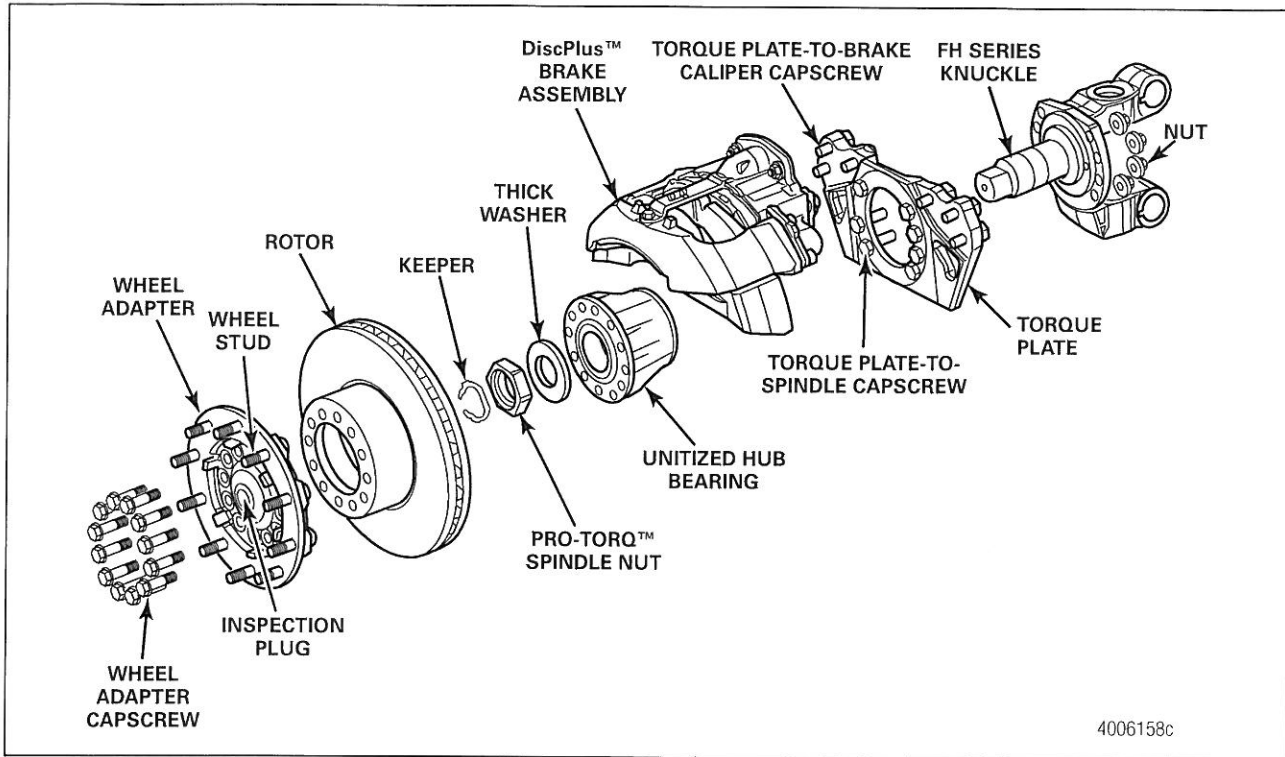
- If hub/rotor/adapter plate bolt torque on any one of the 12 bolts on each unitized wheel end is less than 150 lb-ft (203 N•m): Replace the bolt using ArvinMeritor part number 10X1711. Discard the bolts that were removed. Do not reuse old bolts. Record the bolt replacement on the Inspection Sheet included in this bulletin.

- If any two or more bolts in the same bolt circle on a wheel end are less than 150 lb-ft (203 N•m): Replace all 12 bolts on the untized wheel end using ArvinMeritor part number 10X1711. Remove, replace and tighten each bolt one at a time to maintain the correct clamp load on the wheel end. Discard the bolts that were removed. Do not reuse old bolts. Record the bolt replacement and torque in the Inspection Sheet included in this bulletin.

4. Use a click torque wrench to tighten all remaining bolts and any replacement bolts in a star pattern to  $275 \pm 25$  lb-ft ( $373 \pm 34$  N•m). Record the torque on the Inspection Sheet included in this bulletin. When you have tightened all of the bolts, recheck the torque of all 12 bolts in a star pattern. **ⓘ**
5. Mark a stripe on all of the tightened bolts. Use a different color than the color already used.
