Re: Defect Information Report FL-581, Western Star Idler Arm Spacer

Defect Information Report (Section 573.6)

Brands: Western Star

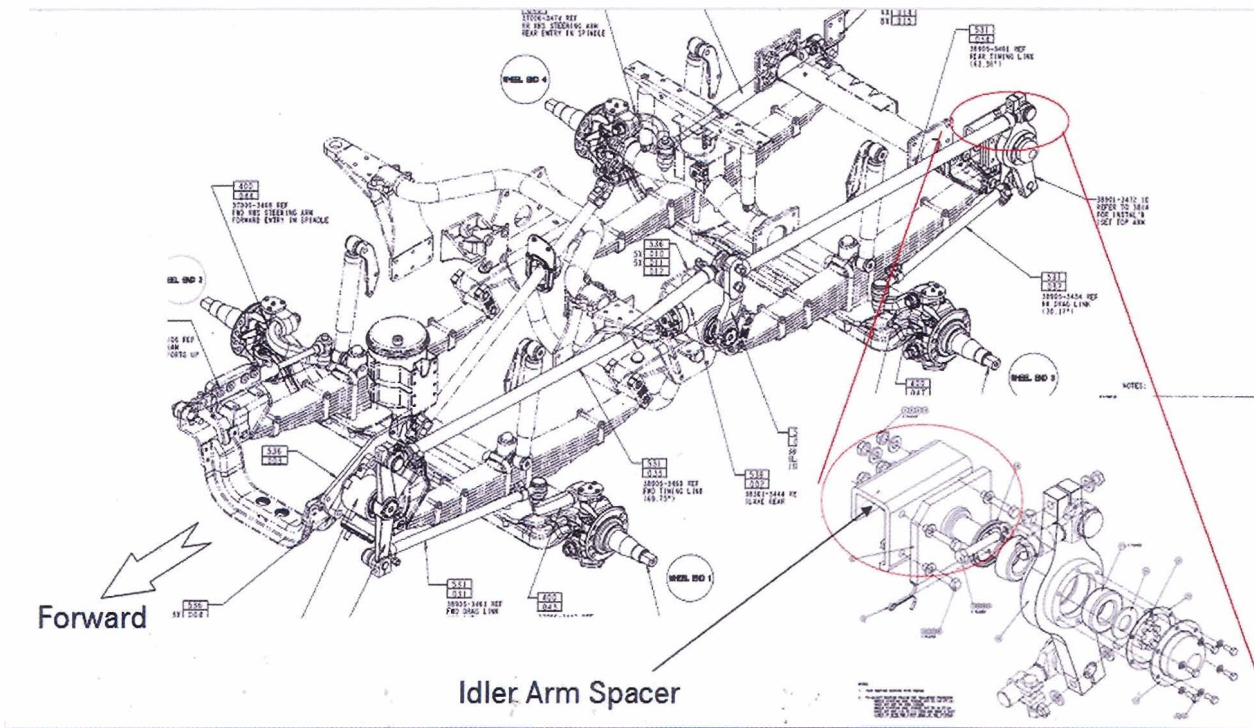
(c)(5) **Description of the defect:** The spacer used to connect the aft steer axle idler arm to the frame rail may develop cracks and eventually break under severe steering conditions allowing the idler arm to separate from the frame rail resulting in diminished steering control.

49CFR Section 577.5(f) Evaluation of the risk to motor vehicle safety: Diminished steering control may lead to crash.

- (c)(6) **Chronology of principal events:** Isolated incidents involving cracked or broken brackets received in 2004 and 2006. DTNA opened an investigation in November 2009 based on customer reports of spacer failures on multiple vehicles. In June 2010 it was determined that the spacer bracket was not capable of withstanding severe loads applied in certain applications.

- (c)(7) **Noncompliance-test or other data:** Not applicable
- (c)(8) (i) **Remedial program:** The tubular shaped spacer bracket will be replaced with a solid spacer block. Repairs will be performed by Daimler Trucks North America dealerships and Direct Warranty customers, i.e., customers approved by Daimler Trucks North America to do their own warranty repairs
Reimbursement Plan: Copies will be submitted as a supplemental report when available.
