RE: Part 573 Defect Information Report – Open Circuit of Steering Roll Connector on 2010 Subaru Legacy & Outback

Defect Information Report (49 CFR Part 573.6)

Our identification code for this recall campaign will be: WVR-28.

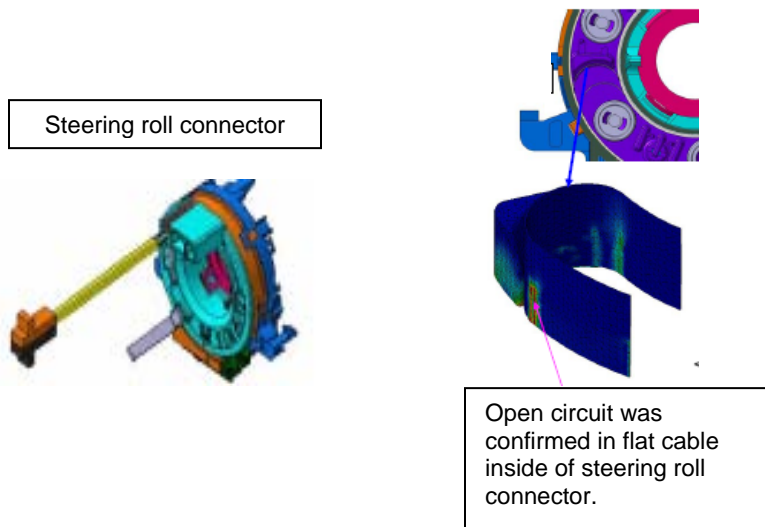
- (1) Technical reports that FHI received from other markets indicated illumination of the airbag warning light, impossible operation of paddle shift, steering wheel radio, cruise control and/or no sounding of horn. The problems are caused by broken lead wire(s) in the flat cable of steering roll connector.

On certain flat cables of the steering roll connector, chemical stress cracking may occur on the cable surface due to manufacturing dispersion of grease which is applied to the cable during the assembling process of the roll connectors. The grease that was used in these particular roll connectors contained higher than normal high free alkali which can damage the copper laminate on the flat cable. With continual use of the roll connector a crack may develop and disrupt the electrical circuits. Possible circuits affected are the driver's frontal airbag, paddle shifter function, cruise control, horn control and radio functions. Over a period of time the grease can creep and affect one or a combination of the circuits.

Chemical stress will not occur after 100 hours of steering roll connector storage regardless of free alkali amount and humidity condition. Even if the initial alkali density is high, it will dissipate to far less than 0.07% with elapse of 100 hours under any atmosphere conditions. This unique characteristic of the grease was difficult to determine and took some investigative time to find out.

The remedy plan calls for dealers to check lot number of the steering roll connector. The roll connector will be replaced with a new one if the lot number showed any affected range of the failure occurrence.
