MITSUBISHI FUSO
TRUCK OF AMERICA, Inc.

**Subject: Safety Recall Notification on the ABS Hydraulic Unit Harness
Model Years: 2008 – 2010; Models: FE83D, FE84D, FG84D
MFTA Safety Recall – C1004210 ABS Hydraulic Unit Harness**

Defect and Noncompliance Information Report

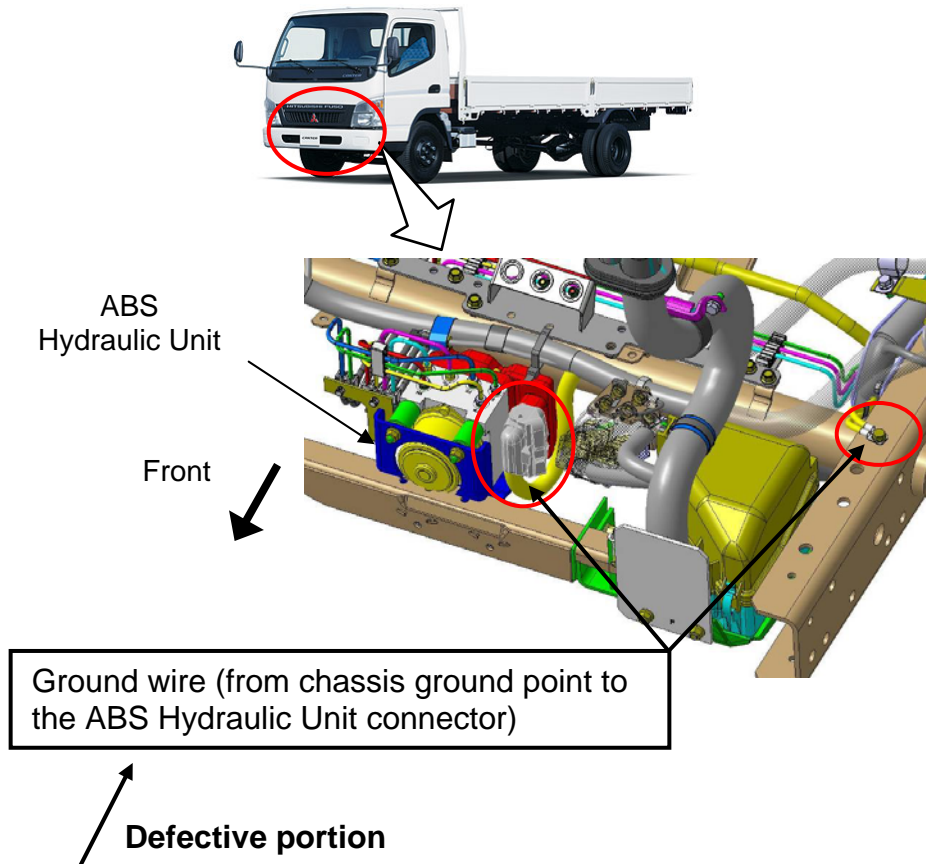
The ground wire on affected vehicles equipped with an anti-lock brake system is positioned in such a manner that water could enter the wire casing and travel to the ABS hydraulic unit connector. If water invasion occurs during normal vehicle operation, the connector terminals could become corroded. In the worst case, the corrosion could affect the hydraulic motor circuit in such a manner that the motor would operate continuously, causing the motor to overheat and start a fire.

After deliberate study of failed parts, MFTBC determined that the failure is caused by the ABS hydraulic unit ground wire, which is positioned in such a manner that it could allow water to enter the wire casing and travel to the ABS hydraulic unit connector. If water invasion occurs during normal vehicle operation, the connector terminals could become corroded. In the worst case, the corrosion could affect the hydraulic motor circuit in such a manner that the motor would operate continuously, causing the motor to overheat and start a fire. MFTA received twenty two (22) Warranty Service Claims (WSCs) and eleven (11) Product Quality Reports (PQRs) relating to affected vehicles. MFTA has received no notice of accident or injury relating to the subject component.

The ground sub harness will be replaced with a properly waterproofed harness. The ABS hydraulic unit will be inspected for corrosion. If corrosion exists, the unit will be replaced. The connector and terminals will be inspected for damage. If damage exists the connector and terminals will be replaced.
