10V-326  
(4 pages)

**RE: Part 573 Defect Information Report – Improper Processing of 6-Speed Manual Transmission Transfer Case on 2010 and 2011MY Subaru Legacy & Outback**

**Defect Information Report (49 CFR Part 573.6)**

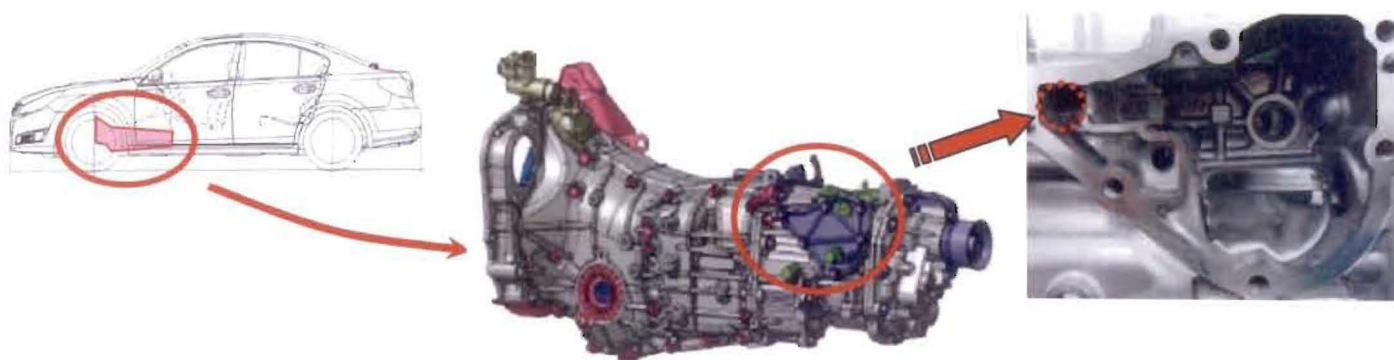
It was discovered at the transmission supplier that the lubrication hole within the 6-speed manual transmission transfer case had not been drilled due to a programming error. The parts in production were checked and it was confirmed that there was no lubrication hole in the transfer case.

The remedy plan calls for dealers to drill an oil lubrication hole in the 6MT transfer case and, if necessary, to replace the internal parts with new ones.

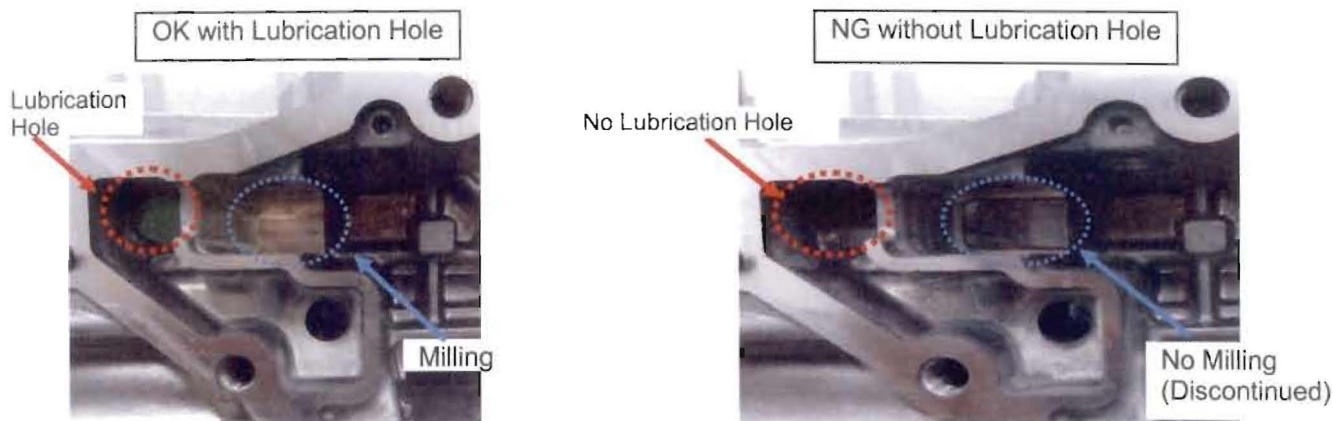
**(2) Cause of the Defect**

When milling at one area (blue circle) of the transfer case was discontinued in the processing program, processing of the lubrication hole (red circle) was erroneously eliminated at the same time.

June 24, 2010: FHI added a processing program to include the oil lubrication hole in the transfer case to correct production vehicles.
