**Re: Defect Information Report – Supplemental Report No. 2  
10V-468 & 10V-472, 10C-6, MBE900 EPA07 Reprogramming**

**Subject: Safety Recall 10C6  
MBE900 EPA07 MCM Reprogramming In School Bus and  
Emergency Vehicle Applications**

# SAFETY RECALL BULLETIN

Subject: **Safety Recall 10C6**  
**MBE900 EPA07 MCM Reprogramming In School Bus and**  
**Emergency Vehicle Applications**

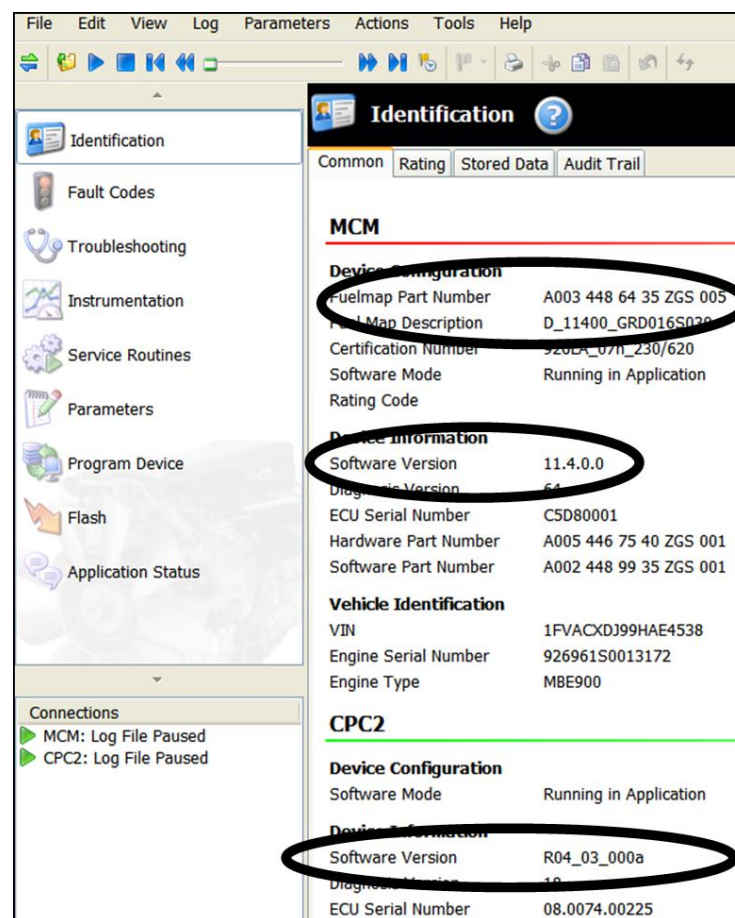
Figure 1 – Software And Fuel Map Version Number

1. Apply the parking brake, chock the wheels, and perform any other applicable safety steps.
2. Using the "Identification" screen in DDRS, check the MCM software level and fuel map version number. See Figure 1. In this example, the MCM software level is 11.4.0.0 and the fuel map version is the last three digits of the fuel map part number after the letters ZGS which is 005.

4. Using the “Identification” screen in DDRS, check the CPC software level. See Figure 1. In this example, the CPC software level is r4.03. If the CPC is not at r4.03 software or higher, program it using the “Update Device Software” option. Select “No Charge”, then “Description”, and enter “10C6” in the “Provide Reference” box.

3. If the MCM is not at software 11.4.0.0 with fuel map version 005 or higher, program it to 11.4.0.0 or higher using the “Update Device Software” option. Select “No Charge”, then “Description”, and enter “10C6” in the “Provide Reference” box.
