Great Dane Trailers

10V-501
(5 Pages)

Re: 10E-047

Lower Axle Seat Weld Inspection and Repair for Meritor RideSentry™ MPA Series Sliding Tandem Trailer Air Suspension Systems

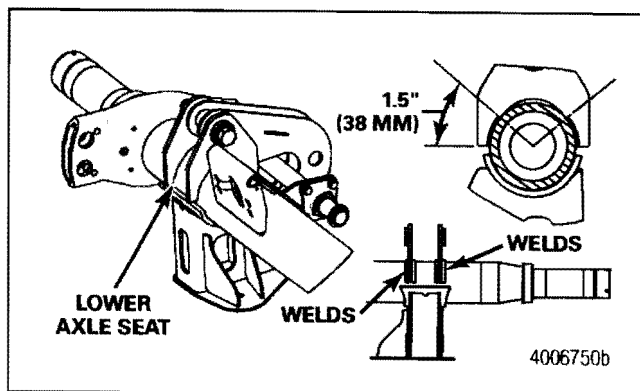
Figure 2

1. Wear safe eye protection. Park the vehicle on a level surface. Block the wheels to prevent the vehicle from moving.
2. From underneath the trailer, inspect the lower axle seat welds as follows.
 - A. Check that there are a total of four welds per axle seat side (two lower axle seats welded on each side). Figure 1.
 - B. Verify the welds are nominally 1.5-inches (38 mm) long and 0.25-inch (6.35 mm) wide on each side of the lower axle seat onto the axle. The welds should not be more than 1.5-inches (38 mm) long. Figure 2.

Do not weld over the end of the lower seats. Weld repairs to the axle seat must not extend more than 1.5-inches (38 mm). Welds longer than this specification may result in premature fatigue fractures to the axle tube. Serious personal injury and damage to components can result.

1. Wear appropriate clothing and eye protection when using welding equipment. Refer to Maintenance Manual 8 for complete welding instructions.
2. Use 0.035 E70 wire and 75/25 gas to weld the missing or incomplete areas. Make each weld 1.5-inches (38 mm) long and 0.25-inch (6.35 mm) wide. Welds should not be longer than 1.5-inches (38 mm). Do not weld over the end of the lower seats. Figure 2.
3. When you have finished, verify there is a total of eight complete welds, (two lower axle seats welded on each side). Continue repairs on the other end of the axle, if necessary.
