PART 573 Defect and Noncompliance Responsibility and Reports

On October 13th, 2010, Timpte Inc. decided that a defect which relates to motor vehicle safety exists in the motor vehicles listed below, and is furnishing notification to the National Highway Traffic Safety Administration in accordance with 49 CFR Part 573 Defect and Noncompliance Responsibility and Reports.

- Timpfe Super Hoppers
- Timpfe American Ag

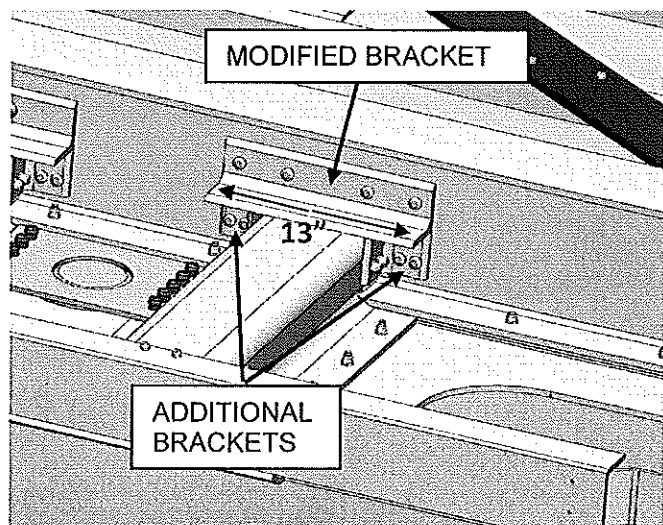
Premature structural failure of front support channels and main support beam.

Product testing in the summer of 2009 resulted in lengthening the original bracket from seven inches to 13 inches and the addition of two new brackets connecting the sides of the front support to the beam. This remedy was incorporated into a test coupler with cracked front supports in order to evaluate its effectiveness in halting
