Miller Electric Mfg. Co.

October 29, 2010

**10V-541  
(3 Pages)**

2. Item of the motor vehicle equipment potentially containing the defect

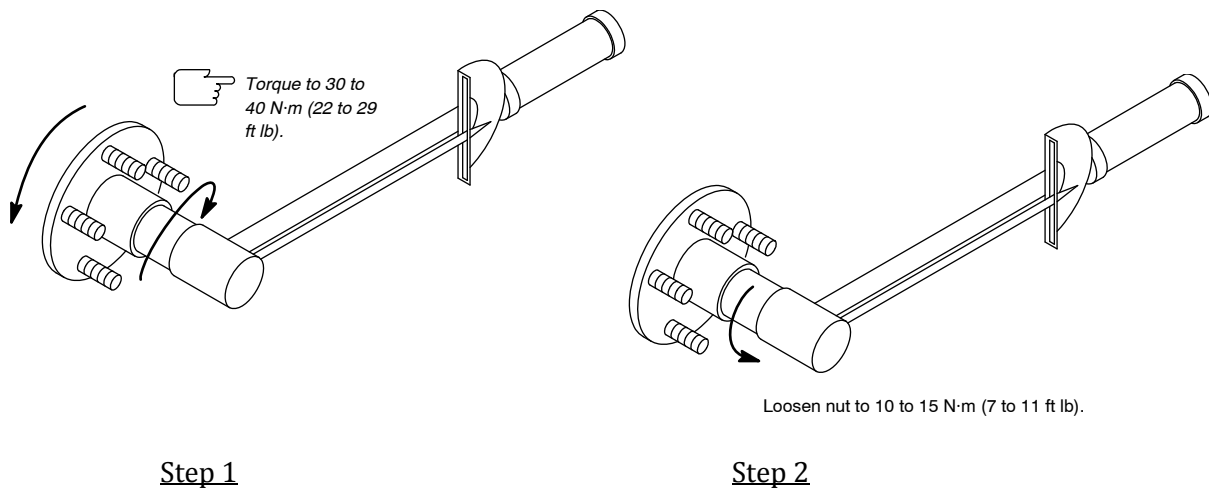
The 3 steps below demonstrate typical procedure for correctly torquing the axle nut. We have identified over-torque as one of the main causes for bearing and hub assembly failure.

One potential solution is to inspect or replace the hub assembly and properly re-install the hub assembly per the above procedure.

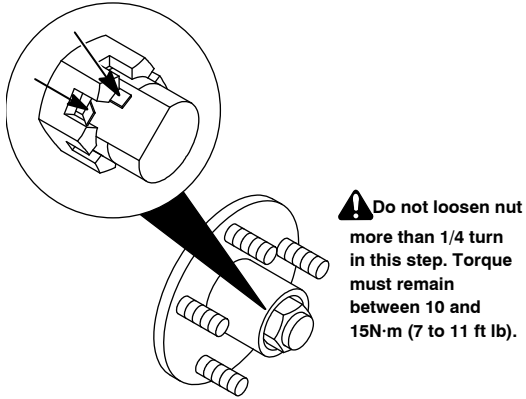
### Step 3

Check to see if slot in nut aligns with one of the tabs on the washer. Bend tab of washer into a slot of the nut.
