Safety Defect and Noncompliance Report Guide for Vehicles  
**PART 573 Defect and Noncompliance Report**<sup>1</sup>

On 19 November 2010, New Flyer Industries Canada ULC [MFR] decided that a defect which relates to motor vehicle safety exists in the motor vehicles listed below, and is furnishing notification to the National Highway Traffic Safety Administration in accordance with 49 CFR Part 573 Defect and Noncompliance Reports.

Furnish the manufacturer's identification code for this recall (if applicable): R10-028

**Make(s):** New Flyer **Model Years Involved:** 2008 **Model(s):** D40LF

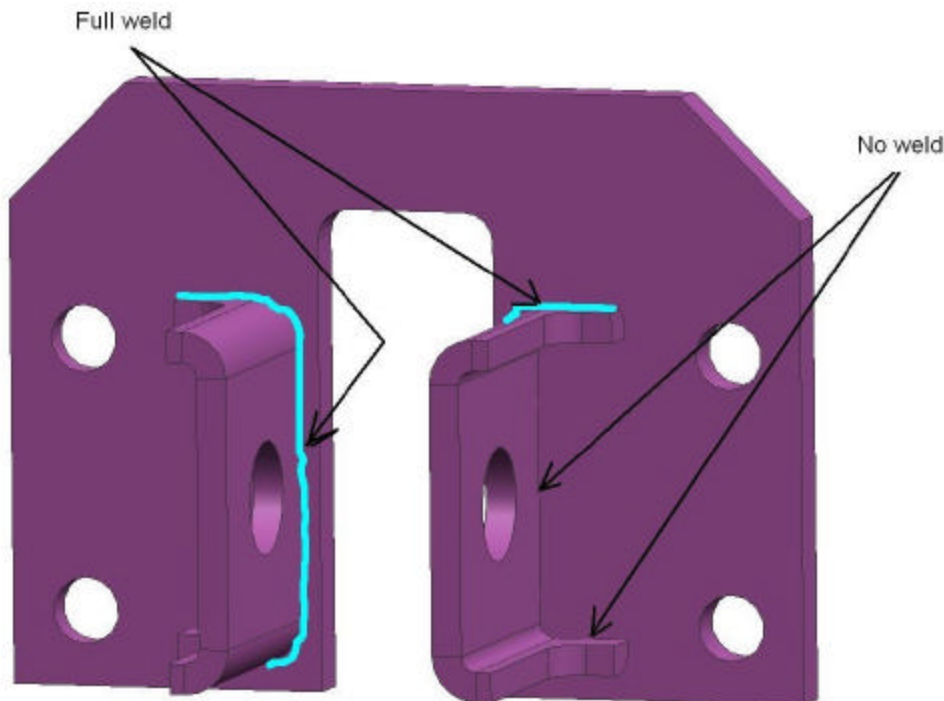
The radius rod brackets are missing two of the four welds required to attached the “ears” of the bracket.

Upon initial inspection, it was determined that the bracket assembly was not built to New Flyer specification. Each bracket assembly has two “ears” welded to the base-plate of the bracket, each ear is to be welded on both sides. The failed bracket was only welded on one side of each ear.

The failed bracket was returned to New Flyer for third party analysis the week of November 8<sup>th</sup>, 2010. The determination of the lab conducting the analysis was that the failed bracket was not only missing two of the four required welds, the existing welds had poor weld penetration. The ears on the failed bracket had cracked and eventually broken off one at a time. Corrosion on one of the ears indicated that there was a time interval of several months between separation of the first and separation of the second ear.

Suspect vehicles identified will be visually inspected for radius rod brackets which are missing welds. Those determined to be missing welds will be replaced with certified product.

Replacement radius rod brackets will have visible welds on both sides of the bracket ears with no indication of rust.
