Service Bulletin

Applies To: 2010 MDX – From VIN 2HNYD2...AH500066 thru 2HNYD2...AH501207

Safety Recall: A-Pillar Trim Bolts May Be Missing

(Supersedes 09-058, dated December 23, 2009, to revise the information marked by the black bars)

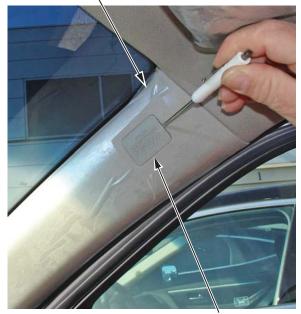
TOP OF A-PILLAR TRIM

Is the A-pillar trim bolt installed?

- If an A-pillar trim bolt is needed, do not use a generic bolt; use the bolt listed under PARTS INFORMATION.
- Be careful not to scratch the A-pillar trim or the cover on the trim.
- 1. Insert a small, flat-tip screwdriver into the slot at the top of the A-pillar trim cover, then carefully pry open the cover.
