TOYOTA CUSTOMER SERVICES

Volume: <u>XVI</u>
Number: <u>TC10-004</u>
Date: <u>02/01/2010</u>

Safety Recall - 90L

Certain 2007 – 2010 Model Year Camry and Camry Hybrid Vehicles Potential Floor Mat Interference with Accelerator Pedal (January, 2010)

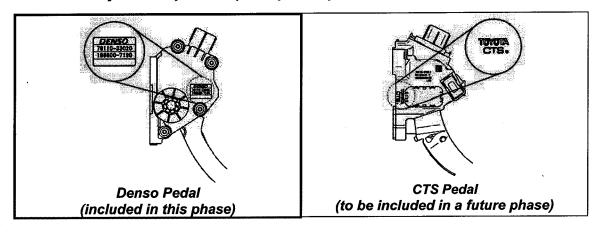
Note:

- The name of the pedal manufacturer is printed (Denso) or embossed (CTS) on the upper sensor housing on the brake pedal side.
- This condition is separate from the Defect Information Report (DIR) filed on 1/21/2010 in reference to the possibility that certain CTS accelerator pedal mechanisms may, in rare instances, mechanically stick in a partially depressed position or return slowly to the idle position.
