TO: All Mazda Dealership General Managers, Service Managers, and Parts Managers
DATE: March 2010
SUBJECT: 2010 CX-9 Seat Warmer Voluntary Safety Recall 5810B

ATTACHMENT I - DEALER INFORMATION
Safety Recall 5810B

2010 CX-9 - SEAT WARMER VOLUNTARY SAFETY RECALL 5810B

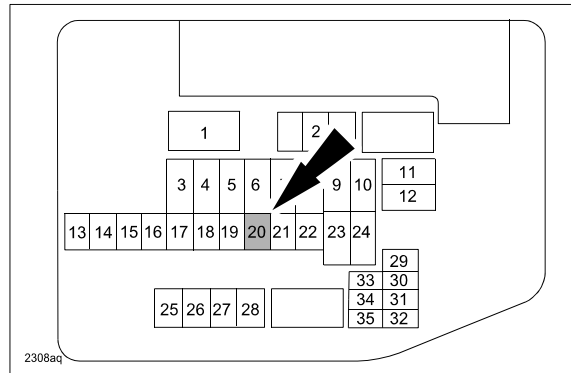
3. Connect the ammeter at the “seat warmer” fuse, and then measure the current.
Caution: Use the ammeter with large capacity
 - A. **The current is approx. 0A:** Both seat warmers are good. (Replacement of seat warmer is not necessary)

- Reinstall the “seat warmer” fuse, and then go to the “PROCEDURE 1” to install the ground cord.
 - B. **The current is approx. 8A:** Both seat warmers are defective.

- C. **The current is approx. 4A:** Either side of seat warmer is defective.
 - Disconnect the seat warmer unit connector on passenger side (A), then measure the current by ammeter again.

- Reinstall the “seat warmer” fuse, and then go to the “PROCEDURE 2” to replace both driver and passenger side seat warmer units, and then go to the “PROCEDURE 1” to install the ground cord.

- The current goes down to approx. 0A:** Passenger side seat warmer is defective.
 - Reinstall the “seat warmer” fuse, and then go to the “PROCEDURE 2” to replace the seat warmer unit on passenger side, and then go to the “PROCEDURE 1” to install the ground cord.

- The current stays approx. 4A:** Driver side seat warmer is defective.
 - Reinstall the “seat warmer” fuse, reconnect the seat warmer unit connector on passenger side (A), and then go to the “PROCEDURE 2” to replace the seat warmer unit on driver side, and then go to the “PROCEDURE 1” to install the ground cord.

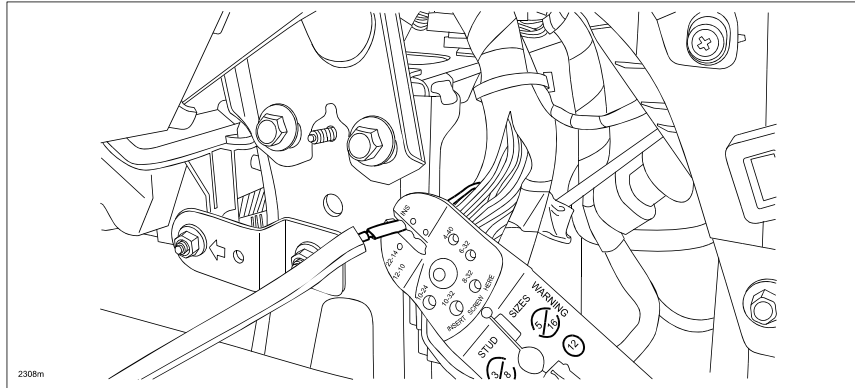
<p>CORRECT CRIMP USING CRIMP TOOL</p> <ul style="list-style-type: none"> • Wires crimped very securely. • No loose or broken wires. • Splice connector intact. 	<p>INADEQUATE CRIMP USING IMPROPER TOOL</p> <ul style="list-style-type: none"> • Broken splice connector. • Possible loose connection.

12. Crimp butt connector onto BR/Y wire. Make sure BR/Y wire is visible at center opening of butt connector.

Tug gently on harness to ensure connection is secure.

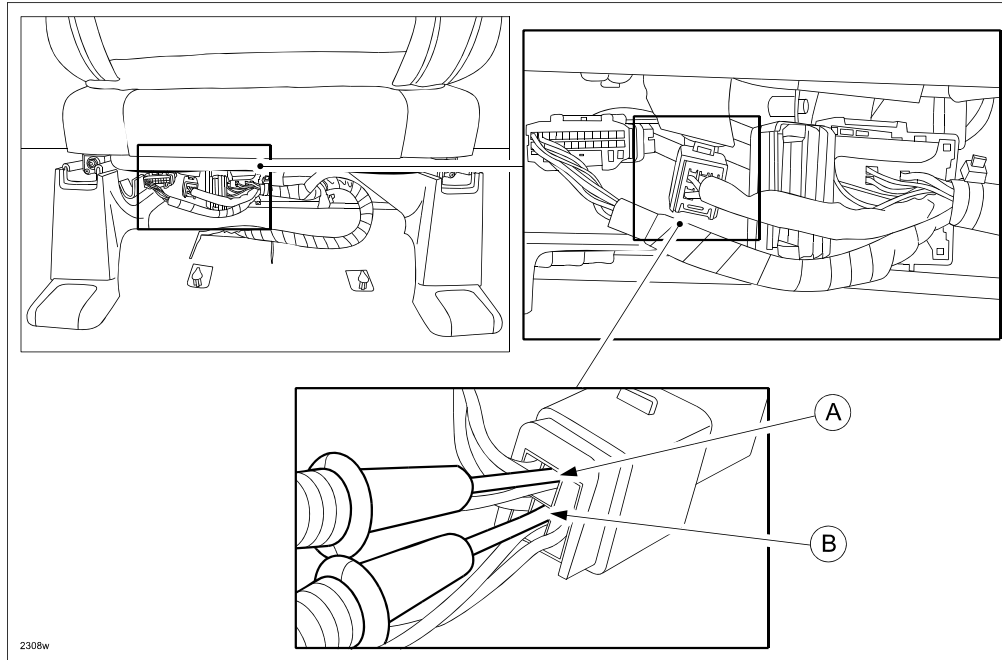
If the measured voltage is different than the specified values in the following table, confirm the repair procedure again. If the measured voltage is within specification, proceed to step 22.

Seat warmer switch position	Voltage readings (Specification)
OFF (no LEDs illuminated)	8 - 12 V
HIGH (two LEDs illuminated)	0.5 - 2 V

21. Confirm grounding wire is connected securely using following voltage check:
- a. Connect the Volt meter terminals to connector as follows (Driver side only). Insert probe (A) on BR/Y wire at driver side connector as shown. Insert other probe (B) at BR/R wire as shown.

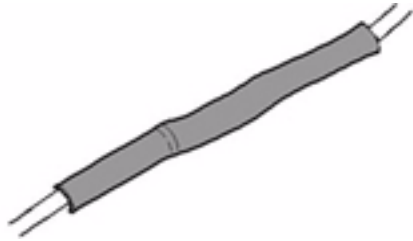
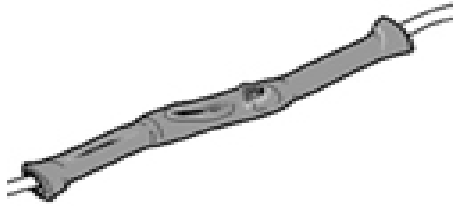
<p>CORRECTLY MELTED HEAT SHRINK TUBING USING FLAMELESS HEAT GUN</p> <ul style="list-style-type: none">• Tubing melted smooth across entire length.	<p>INADEQUATELY MELTED HEATED SHRINK TUBING</p> <ul style="list-style-type: none">• Tubing charred from overheating.• Ends not fully melted.

22. Position heat shrink tube over the butt connector. Using heater-drier, apply heated air until tubing shrinks securely.
