# **TOYOTA CUSTOMER SERVICES**

Subject: Filing of Defect Investigation Report  
Front Propeller Shaft Inspection

February 11, 2010  
TMS-NTC-10019

Certain 2010 Model Year 4WD Tacoma Vehicles  
Front Propeller Shaft Safety Recall  
\*\*\*\*\*URGENT\*\*\*\*\*

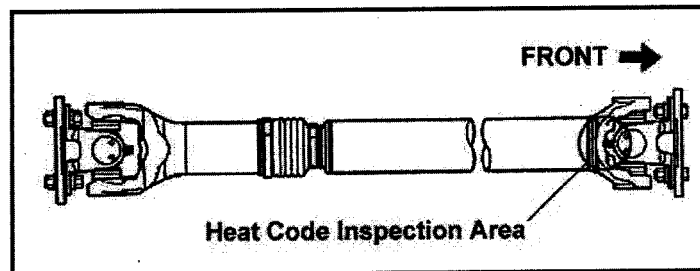
- On some 2010 Model Year Tacoma 4WD vehicles, the joint portion of the propeller shaft may include a component that contains cracks that developed during the manufacturing process. As those vehicles are used, the cracks may eventually lead to the separation of the propeller shaft at the joint portion, and the separated shaft may come into contact with the road surface. In the worst case, this may result in a loss of vehicle control.
- The subject front propeller shafts are manufactured by Dana and can be identified as shown below:

- Toyota is in the process of preparing the remedy for the involved vehicles. Additional details, including technical and reimbursement instructions, will be provided in the Safety Recall package to be sent shortly.
- The attached Dealer Daily Message will be sent to all dealerships informing them of the DIR filing.
- A Q&A has been attached for your reference.

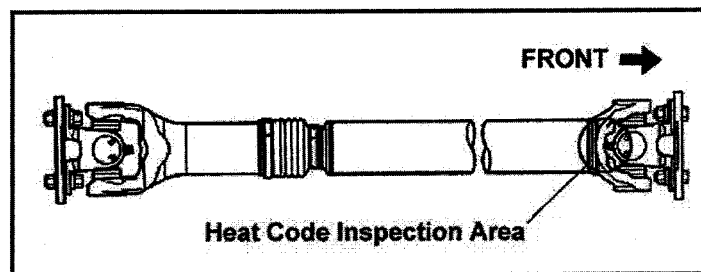
- On some 2010 Model Year Tacoma 4WD vehicles, the joint portion of the propeller shaft may include a component that contains cracks that developed during the manufacturing process. As those vehicles are used, the cracks may eventually lead to the separation of the propeller shaft at the joint portion, and the separated shaft may come into contact with the road surface. In the worst case, this may result in a loss of vehicle control.
- The subject front propeller shafts are manufactured by Dana and can be identified as shown below:
